Building Information - Buckeye Local SD (45856) - Edgewood High School

Building Pictures - Buckeye Local SD(45856) - Edgewood High School(9936)

Building Construction Information - Buckeye Local SD (45856) - Edgewood High School (9936)

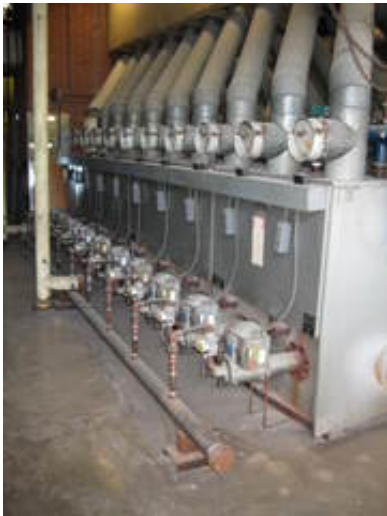
Description: Heating system consists of eight natural gas fired hot water boilers installed in 1985 that are in fair condition. Combustion air does not meet OBC requirements. Two natural gas fired roof top air units provide make up air to two science rooms when fume hoods are operating. The media center and several support areas are served by a split system (D/X and hot water), air rooftop handler installed in 1982. Space comfort heating is provided via unit ventilators. Heating water system pumps and piping specialties were installed in 1961 and are in fair condition. Controls are combination DDC/pneumatic. DDC system was installed in 2002 and is linked to a central monitor in the Junior High School. The computer labs contain rooftop mounted condensing units supplying packaged wall mounted air conditioners. The administrative office area contains pad mounted condensing units and a combination of wall mounted and window mounted air conditioning units. Heating system is near the end of its service life. The system is not capable of providing Ohio Building Code fresh air requirements. According to school officials, the site does not contain underground fuel tanks.

Rating: 3 Needs Replacement

Natural gas boilers

Recommendations: Provide new overall heating system, including air conditioning, to meet Ohio School Design Manual guidelines. Provide funding to convert existing non-ducted system (1961 original construction and 1961 auditorium) to ducted air system.

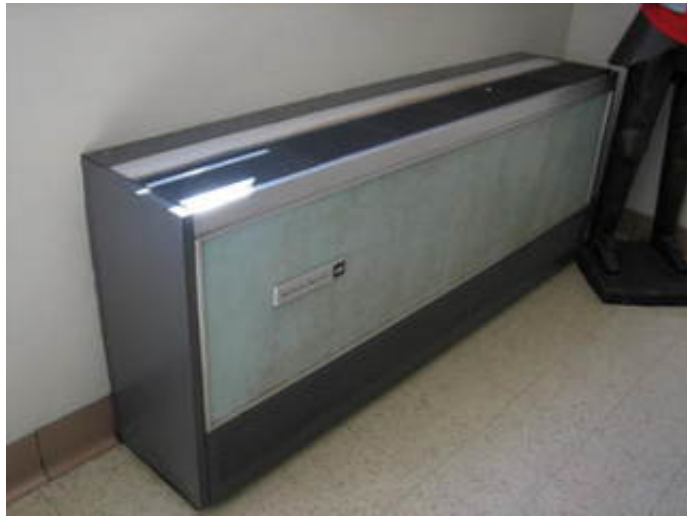
Classroom unit ventilators

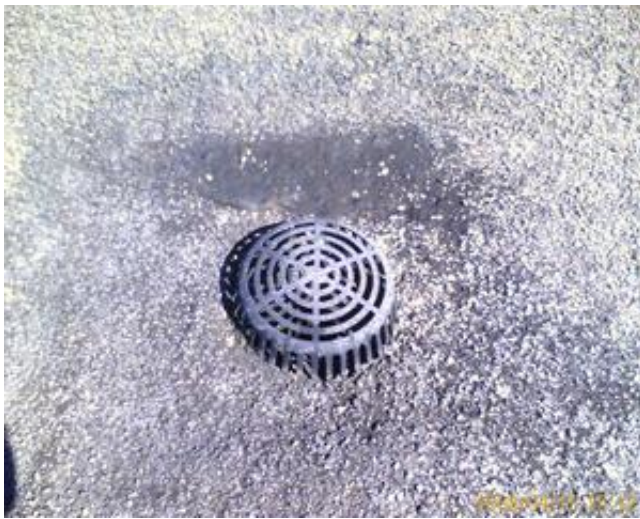
Description: The roof over the 1961 original construction is a combination of an asphalt built-up ballasted system, (no installation date was available at time of assessment), and is in good to fair condition, and an EPDM fully adhered membrane system that was installed in 2005, 2006, and 2007, and is in good condition. The roof over the 1961 auditorium is an asphalt built-up ballasted system, (no installation date was available at time of assessment), and is in good to fair condition. The roof over the 1972 addition is an EPDM fully adhered membrane system that was installed in 2007, and is in good condition. There are no district reports of current leaking. Signs of past leaking were observed during the physical assessment. Access to the roof was gained by a combination of access door, roof hatch, and access ladder that are in good condition. There were observations of standing water on the roof. Metal cap flashings and copings are in good condition. Roof storm drainage is addressed through a combined system of roof drains, gutters, and downspouts, which are properly located, and in good condition. The roof is not equipped with overflow roof drains though they will be required in areas of roof replacement. No problems requiring attention were encountered with any roof penetrations. There are not any covered walkways attached to this structure. April 2019 Update: The OFCC guidelines for single ply membrane roofing is if that roof system exceeds 7 years it is recommended it be replaced. The roof over the 1972 Media Center Addition that was installed in 2007 now exceeds the 7 year replacement guidelines. Additional roof insulation will be required for all roof areas to meet LEED Silver Certification Energy Efficiency Requirements.

Rating: 3 Needs Replacement

Typical roof drain condition

Recommendations: The asphalt built-up roofing system over the 1961 original construction and the 1961 auditorium requires replacement to meet Ohio School Design Manual guidelines for age of system and due to condition. To facilitate the school's compliance with OBC, provide new overflow roof drains in areas of roof replacement. April 2019 Update: Replace the roof on the 1972 Media Center Addition. Provide additional roof insulation on 1961 Original Building, 1961 Auditorium Addition and 1972 Media Center Addition.

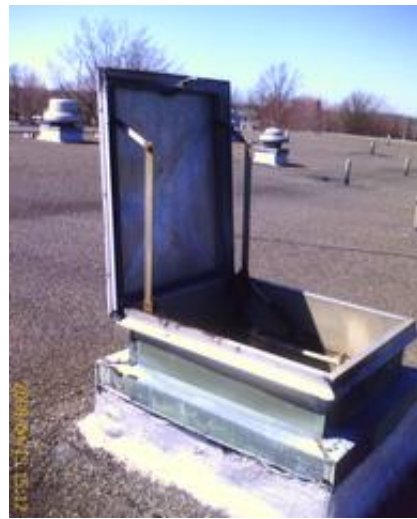
Typical roof hatch condition

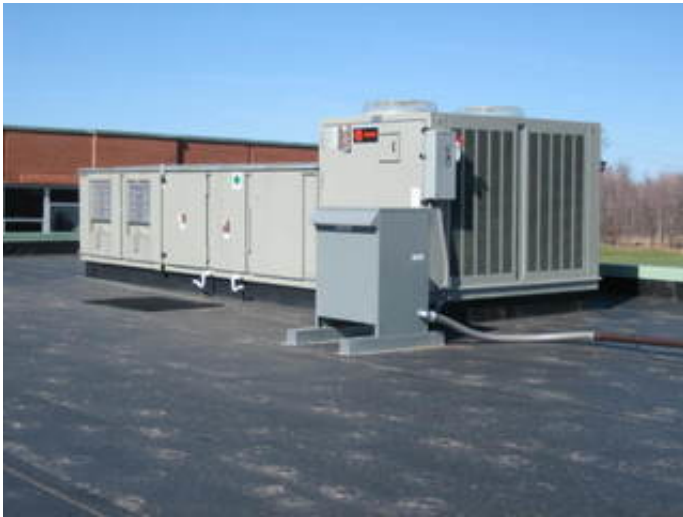
Rooftop packaged chiller unit

Recommendations: Provide an air conditioning system throughout the overall facility to meet Ohio School Design Manual guidelines. Funding included in Item A - Heating System.

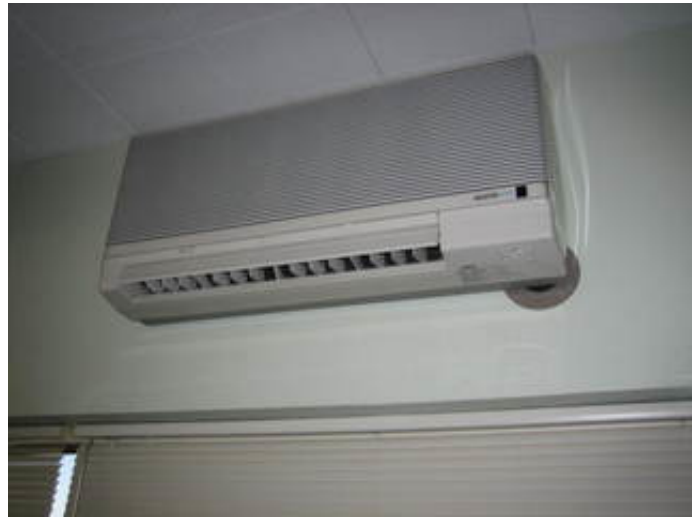
Packaged wall mounted air conditioning unit

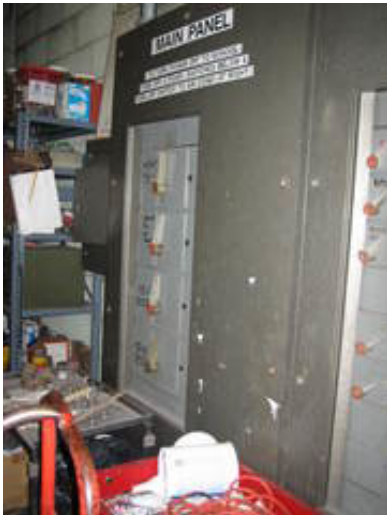
Description: The electrical system for the overall facility consists of a 208v, 1400-amp, 3-phase, wire system fair condition. The system was installed with the original construction in 1961. The transformer is owned by the utility company and is located in the building in a transformer vault. The panel system is in poor condition. The panel system was installed in 1961 and cannot be expanded for additional capacity. Classrooms are equipped with adequate electrical outlets as several upgrades have provided additional surface mounted electrical receptacles. Corridors of the building are equipped with adequate electrical outlets for building maintenance. The exterior of the building is not equipped with adequate electrical outlets for building maintenance. The facility does not contain lightning protection with grounding. April 2019 Update: The individual line items for Transformer Removal, New Pad Mounted Transformer, Lightening Protection and Building Grounding are included in the scope and budget for complete System Replace and those individual line items should be deleted.

Rating: 3 Needs Replacement

Main distribution panel

Recommendations: The entire electrical system requires replacement to meet Ohio School Design Manual guidelines for classroom capacity, the addition of an air conditioning system and due to age. The emergency generator for life safety systems is included in the entire electrical system replacement funded in this Item D - Electrical. Remove vault mounted transformer and provide new pad mounted transformer. Provide building lightning protection and grounding. April 2019 Update: Delete the individual line items for Transformer Removal, New Pad Mounted Transformer, Lightning Protection and Building Grounding.

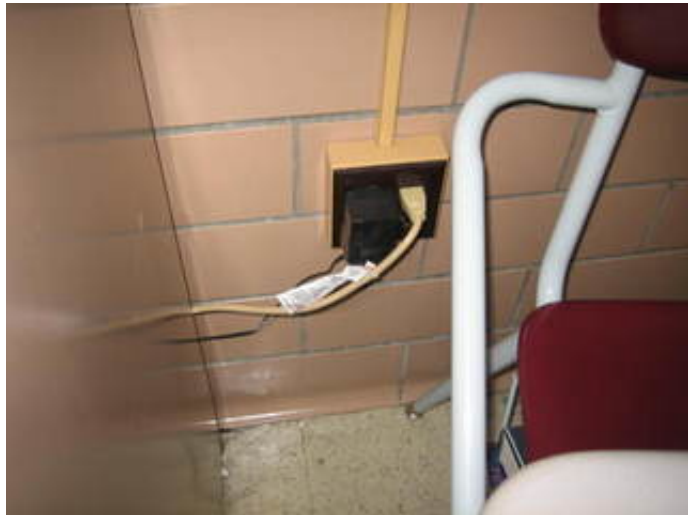
Additional classroom receptacles

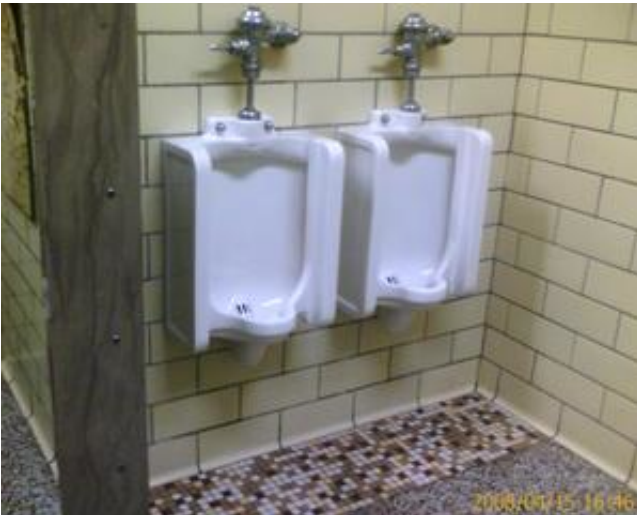
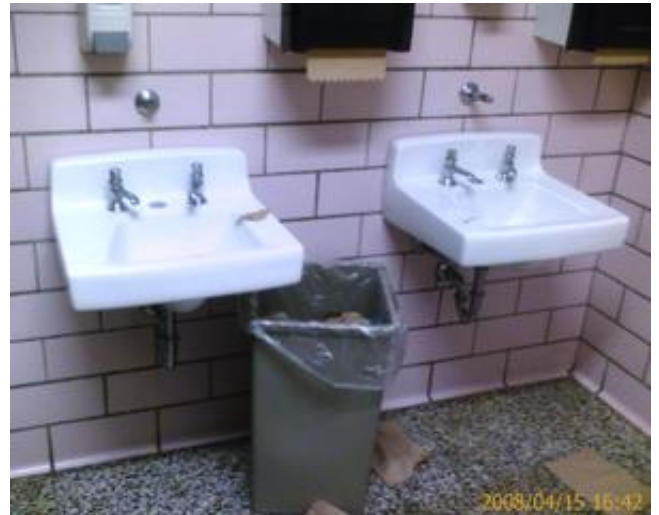
Description: A back flow preventer is not provided. The facility does not contain a water treatment system. Domestic supply piping is copper in adequate condition. Sanitary waste piping is cast-iron in adequate condition. The domestic water heater is a natural gas unit with separate storage tank and is in fair condition. The school contains 4 large group restrooms for boys, 4 large group restrooms for girls, 2 locker room restrooms for boys, 1 locker room restroom for girls, and 2 restrooms for staff. Condition of fixtures is good. The facility is equipped with 6 non-ADA drinking fountains, as well as 4 ADA electric water coolers, in good condition. Special education classroom is not equipped with the required restroom facilities. Kitchen is equipped with the required restroom facilities and fixtures are in good condition. Health clinic is equipped with the required restroom facilities, and fixtures are in good condition. Due to existing grade configuration, there are no kindergarten / pre-K classrooms. Kitchen fixtures consist of 1 single, 1 double, and 1 3-well sinks, as well as 1 lavatory, 1 dishwasher, and 1 garbage disposal unit, which are in good condition. The school meets the OBC requirements for fixtures except for lavatories and electric water coolers. ADA requirements are not met for fixtures and drinking fountains (see Item O). Custodial closets are properly located and are adequately provided with required service sink which is in good condition. Science classrooms / project laboratories are not equipped with required compressed air connection but are equipped with required utility sink, gas / connections, and safety shower / eyewash station in good condition. Adequate exterior hose bibbs are provided. April 2019 Update: Due to age and condition the sanitary waste piping warrants replacement in the 1961 Original Building.

Rating: 2 Needs Repair

Typical fixture condition

Recommendations: Provide back flow preventer at water service entry. To facilitate the school's compliance with OBC and OSDM guidelines provide new lavatories, new electric water coolers, and new compressed air connections. Due to condition and OSFC standards, replace faucets and valves. See Item O for replacement of fixtures related to ADA requirements. No work required in the 1961 auditorium and 1972 addition. April 2019 Update: Provide for replacing the sanitary piping in the 1961 Original Building.

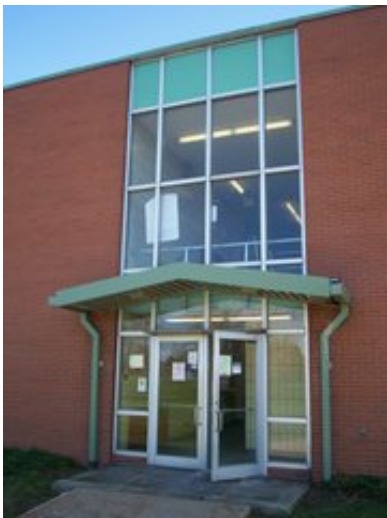
Curtain wall window system

Recommendations: Provide a new insulated window system with integral blinds to meet with Ohio School Design Manual requirements. Replace curtain wall systems, transoms, and sidelights in the original construction with insulated window systems. Replace skylights in the original construction due to age and condition. No work is required in the 1961 auditorium and 1972 media center addition, as no windows exist in these areas.

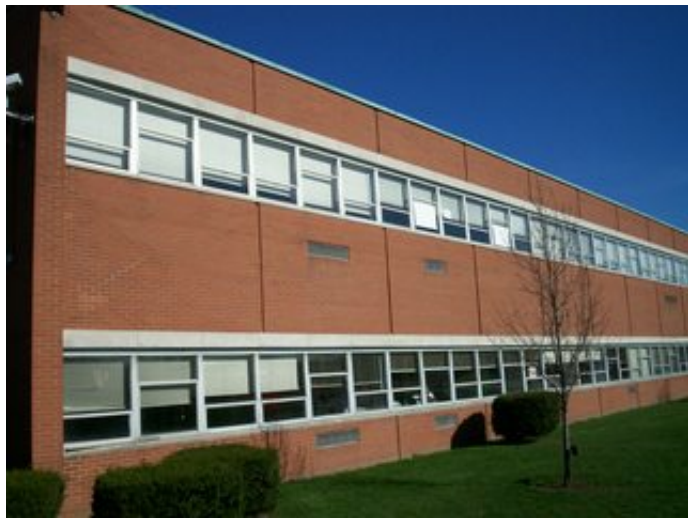
Description: The overall facility is equipped with aluminum frame windows with a single glazed type window system, which was installed in 1961, and is in poor condition. Window system seals are in fair to poor condition, with moderate air and water infiltration being experienced. Window system hardware is in fair condition. The window system features surface mounted blinds, which are in fair condition. The window system is not equipped with insect screens on operable windows. Aluminum frame curtain wall systems are found in the original construction, in fair condition. This facility does not feature any glass block windows. A few windows have been replaced with insulated window panels, but are installed on non-thermally broken aluminum frames. The exterior doors in the overall facility are equipped with hollow metal framed sidelights and transoms with a single glazed window system, in fair to poor condition. The school does contain 42 acrylic bubble type skylights in fair to poor condition. Window security grilles are not provided for ground floor windows. There is not a greenhouse associated with this school.

Rating: 3 Needs Replacement

Typical non-insulated windows

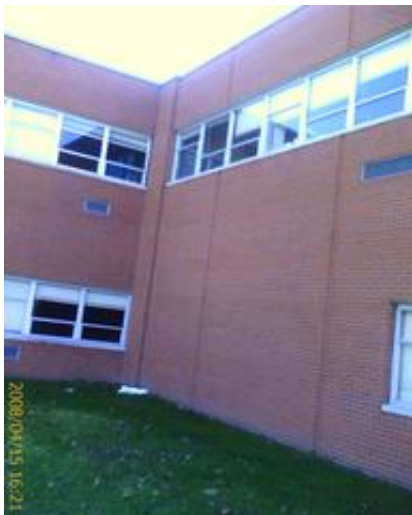
Description: The overall facility has a combination of a brick veneer on a masonry load bearing wall system and a steel framed system, which displayed no locations of significant deterioration, and is in good condition. The exterior masonry appears to have inappropriately spaced but adequately caulked control joints in good condition. Control joints are not provided at lintel locations at doors and windows. The school has sufficient expansion joints, and they are in good condition. The exterior masonry has not been cleaned and sealed in recent years, and show minor evidence of mortar deterioration. Interior walls are concrete masonry unit, glazed block and metal stud framed partitions with gypsum board, and are in good condition. Interior masonry appears to have adequately spaced and caulked control joints in good condition. Soffits are in good condition. Window sills are a combination of stone and an element of the aluminum window system, and are in good condition. Exterior lintels are steel, and are in good condition. Chimneys are in good condition. Canopies over entrances are steel framed with metal deck type construction, and are in good condition. April 2019 Update: The tuckpointing sf quantities for the 1961 Original Building is inadequate and should be increased. Installation of the new HVAC system will require removal of the cabinet unit heaters and masonry infill will be required at the outside air grilles. Movement and significant masonry cracks observed on the east elevation.

Rating: 2 Needs Repair

Typical exterior wall condition

Recommendations: Provide tuckpointing in all areas of mortar deterioration as required throughout the overall facility. Provide exterior masonry cleaning and sealing as required throughout the overall facility. Sawcut and caulk new appropriately spaced control joints in existing exterior masonry throughout the overall facility. No work required in the 1972 addition. April 2019 Update: Increase tuckpointing sf quantity in the 1961 Original Building from 350 sf to 3,839 sf. Provide masonry infill at unit ventilator outside air grilles. Provide budget to repair masonry cracks at east elevation. Recommended the district hire a Structural Engineer to investigate the cracking and settlement creating this issue.

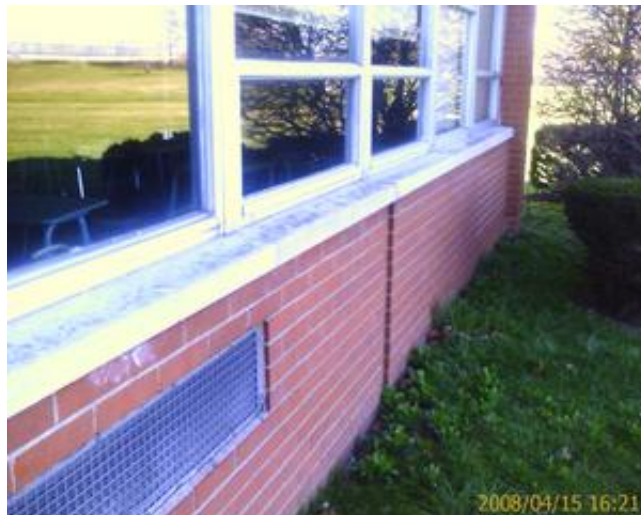
Typical stone sill

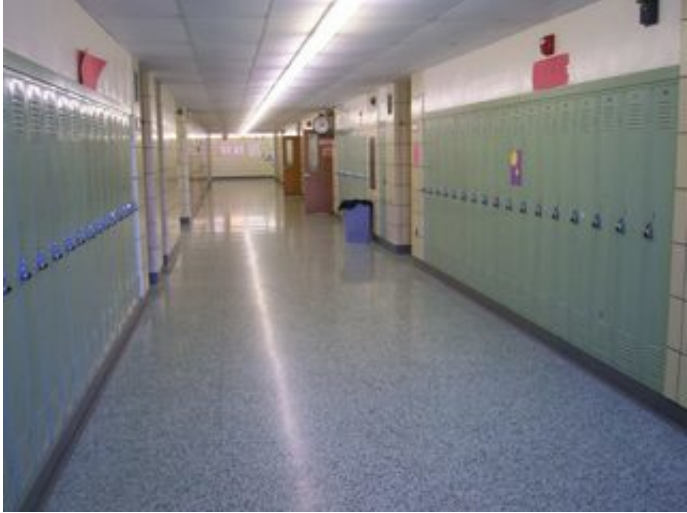
Description: The overall facility features conventionally partitioned classrooms with VAT flooring, acoustical tile ceilings, and glazed block and plaster type wall finishes, which are in fair to poor condition. Corridors have terrazzo flooring, lay-in ceilings, and glazed block and plaster type wall finishes, which are in fair condition. Restrooms have terrazzo flooring, acoustical tile ceilings, and glazed block wall finishes, which are in fair to poor condition. Toilet partitions are marble type construction with metal doors, and are in poor condition. Classroom casework consists of miscellaneous wood and metal shelving units, is inadequately provided, and in poor condition. Classrooms are provided with adequate chalkboards, markerboards, and tackboards, which are in fair condition. The lockers, located in the corridor, are adequately provided, and in fair condition. The facility is equipped with wood non-louvered interior doors that are partially recessed without proper ADA clearances, and are provided with a combination of ADA compliant and non-compliant hardware. The gymnasium space has wood flooring, exposed bar joist and metal deck type ceiling, and painted block and glazed block type wall finishes, which are in fair condition. Gymnasium telescoping stands are wood type construction in fair to poor condition. Gymnasium basketball backboards are manually operated, and are in good condition. The media center, located in the 1972 addition, has VAT flooring, lay-in ceilings, and plaster type wall finishes, and they are in fair condition. Student dining, located in the original construction, has terrazzo flooring, lay-in and acoustical tile ceilings, and plaster and brick type wall finishes, which are in fair to poor condition. The existing kitchen is full service, is undersized based on the current enrollment, and the existing equipment has an unknown installation date, and is in poor condition. A walk-in cooler and freezer are located within the kitchen space, and are in fair to poor condition. April 2019 Update: Additional wall insulation required at 1961 Original Building and 1961 Auditorium Addition to meet LEED Silver Certifications Energy Efficiency Requirements. The fixed seating in the 1961 Auditorium and carpeting are old and worn and warrant replacement. Plaster ceiling patch requires to facilitate installation of fire protection system. The stage curtain at the 1961 Auditorium requires fire treatment. Sound system and new lighting required in 1961 Auditorium.

Rating: 3 Needs Replacement

Typical corridor finishes

Recommendations: Provide complete replacement of finishes and casework due to installation of systems outlined in Items A, C, D, E, K, L, M, N, T, U, and due to condition. Provide plaster refinishing due to condition and work outlined in Items A, C, D, E, K, L, M, N, T, and U. Funding for replacement of interior doors is provided in Item O, including doors here noted as being in poor condition. Provide for repairs to terrazzo flooring due to condition. Provide for removal and replacement of wood flooring in the gymnasium due to age and condition. Provide for replacement of bleachers in the gymnasium due to age and condition. Provide for replacement of toilet partitions due to work outlined in Item O, and due to condition. Provide for replacement of toilet accessories due to age and condition. Provide for replacement of kitchen equipment due to age and condition of equipment. April 2019 Update: Provide for additional wall insulation at at 1961 Original Building and 1961 Auditorium Addition. Provide for carpet replacement and replacement of new seats in 1961 Auditorium. Replace sound system and lighting in 1961 Fixed Seat Auditorium. Provide for plaster ceiling patch following installation of fire protection system. Provide for fire treatment/fire dipping of stage curtain at the 1961 Auditorium.

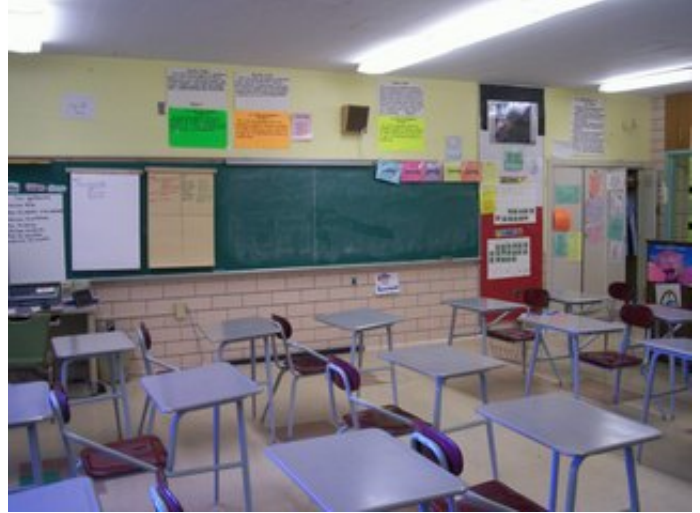
Typical classroom finishes

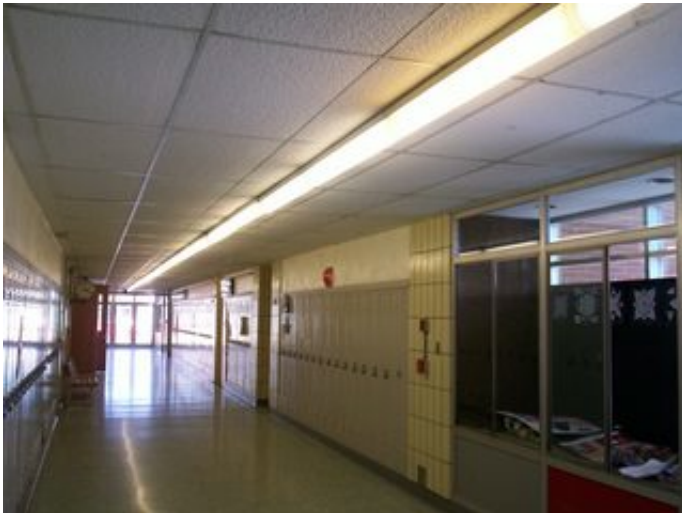
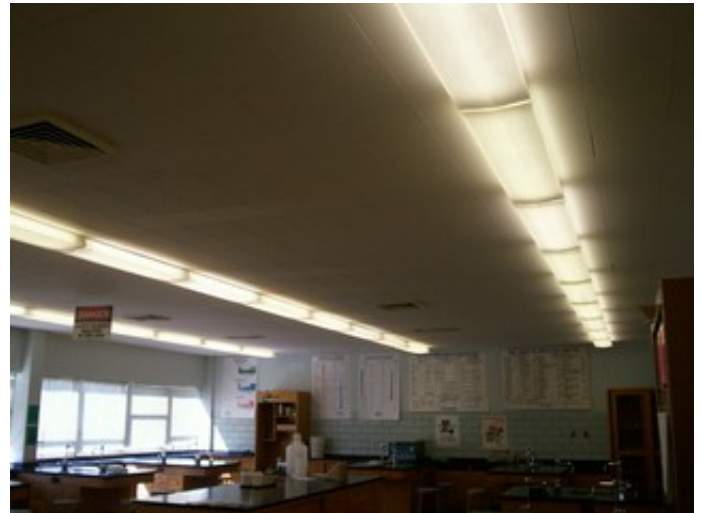
Rating: 3 Needs Replacement

Typical corridor lighting

Typical classroom lighting

Recommendations: Provide complete replacement of lighting system due to condition, lighting levels, and installation of systems outlined in Items A, C, D, J, L, M, N, and U.

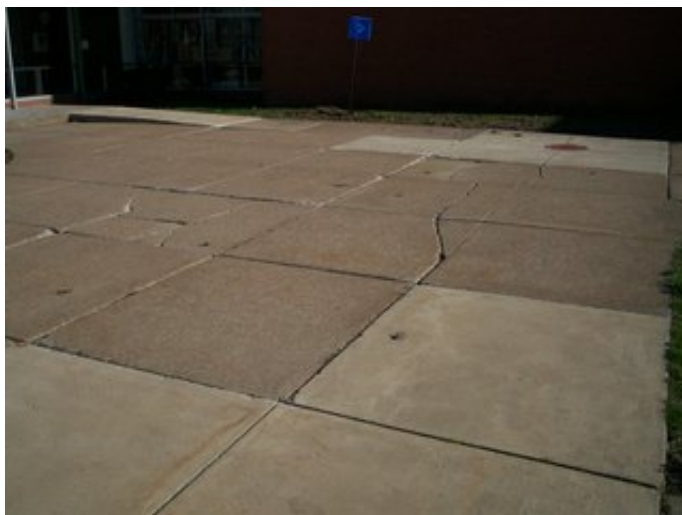
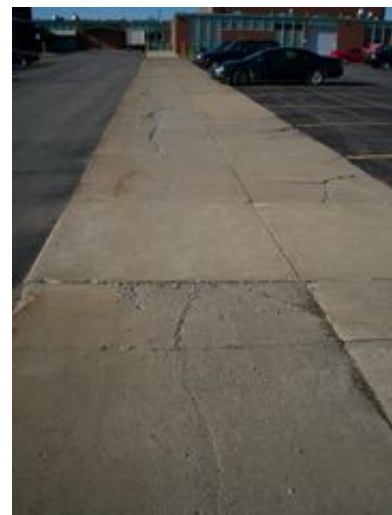
Concrete sidewalk in poor condition

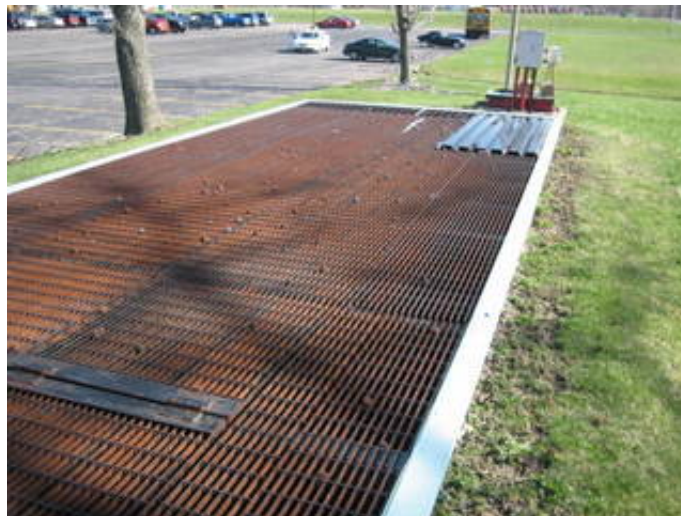
Waste water treatment plant

Recommendations: Remove and replace on-site sewage treatment system based upon current student enrollment of building at funding levels indicated below. Remove and replace on-site sanitary sewer main.

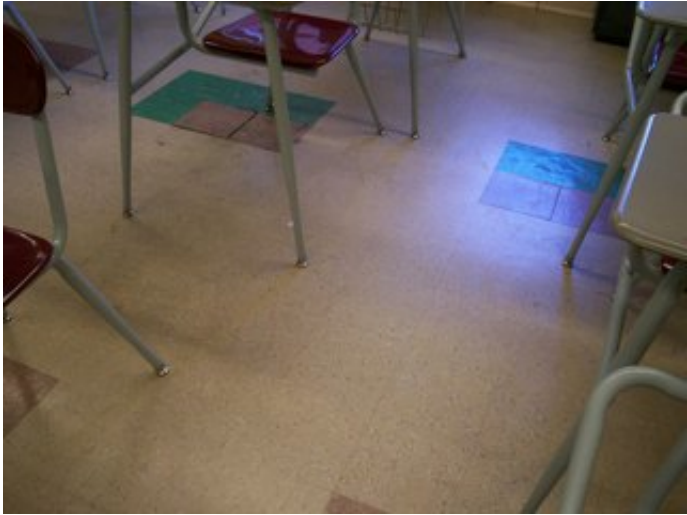
VAT in classrooms

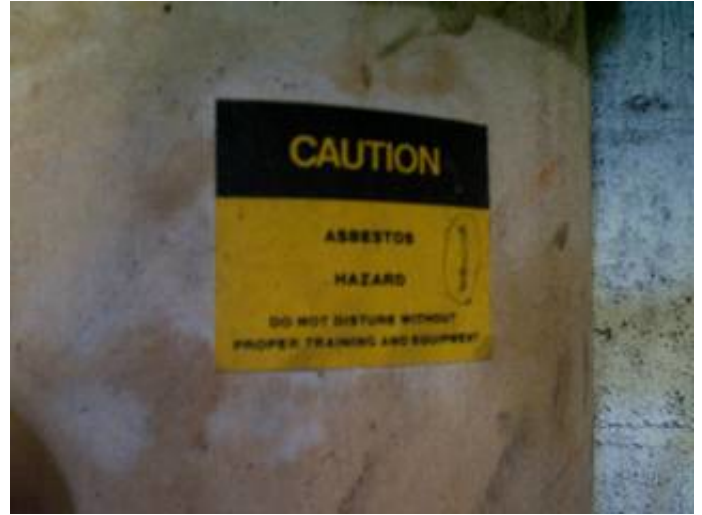
Asbestos label in boiler room

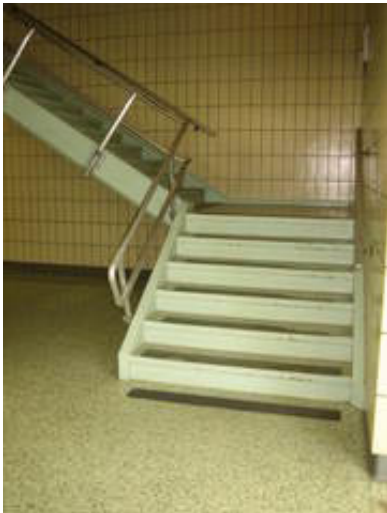
Non-enclosed stair with non-compliant handrails

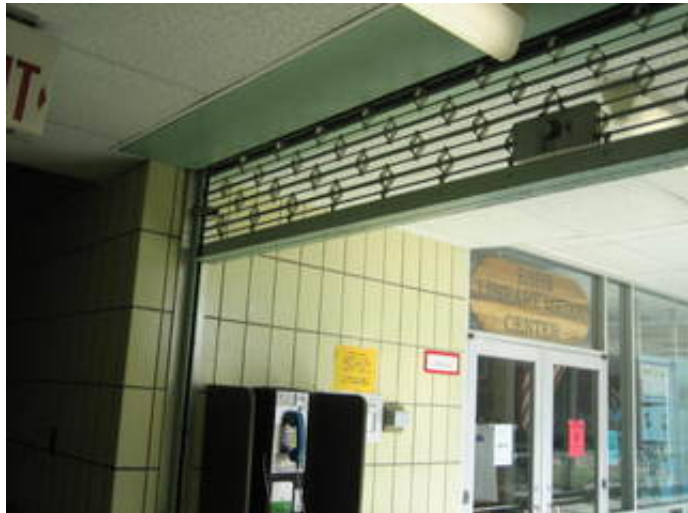
Corridor security gate

Other: Remove corridor security gates	\$1,500.00	each		4 Required			\$6,000.00	Provide for removal of corridor security grilles to eliminate dead-end corridor conditions when they are in the closed position.
Sum:			\$537,226.60	\$487,439.40	\$28,726.80	\$21,060.40
