Building Information - Buckeye Local SD (45856) - Ridgeview Elementary School

Building Pictures - Buckeye Local SD(45856) - Ridgeview Elementary School(31682)

GENERAL DESCRIPTION

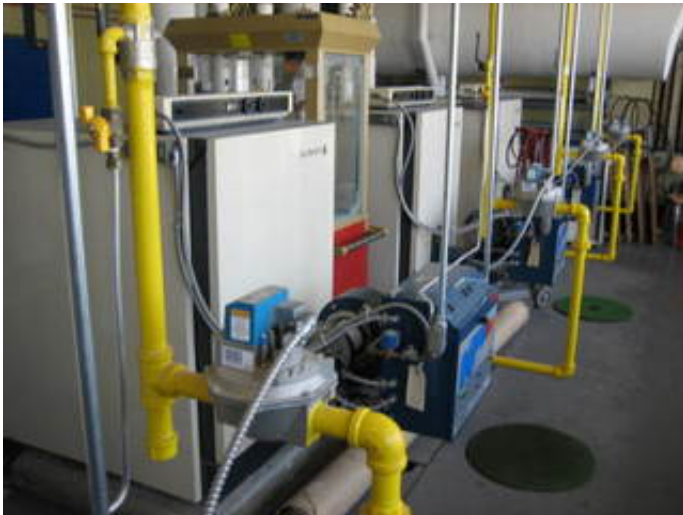
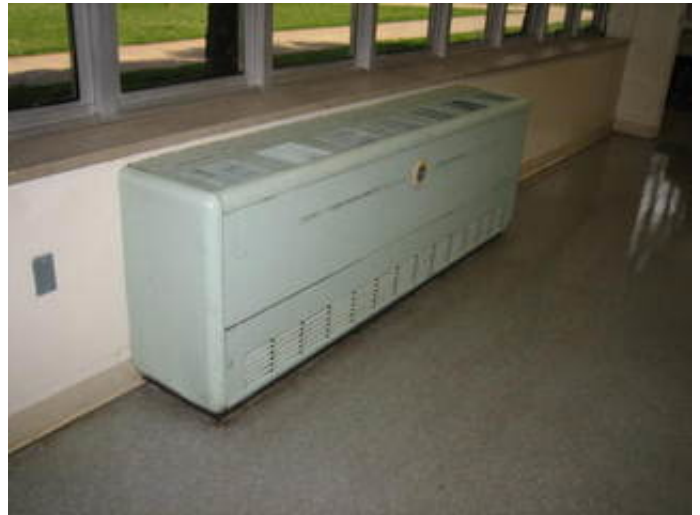
Description: The existing system for the overall facility consists of four (4) DeDietrich natural gas fired water boilers that provide hot water to unit ventilators. The system is in fair condition. The unit ventilators are original to the 1957 original construction. The gas fired boilers were replaced in 2002. Existing controls are a combination of pneumatic and digital and were installed with the 1957 original construction and partially upgraded in 2002. The system is not capable of providing Ohio Building Code fresh air requirements. The facility contains window air conditioning units in the administrative office area. According to school officials, the site does not contain underground fuel tanks.

Rating: 3 Needs Replacement

Four (4) hot water boilers

Unit ventilator

Recommendations: Provide new overall heating system, including air conditioning, to meet Ohio School Design Manual guidelines. Provide funding to convert existing non-ducted system to ducted air system.

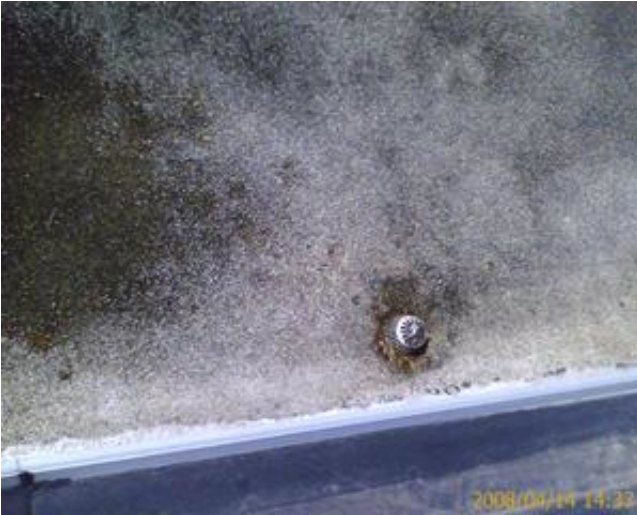
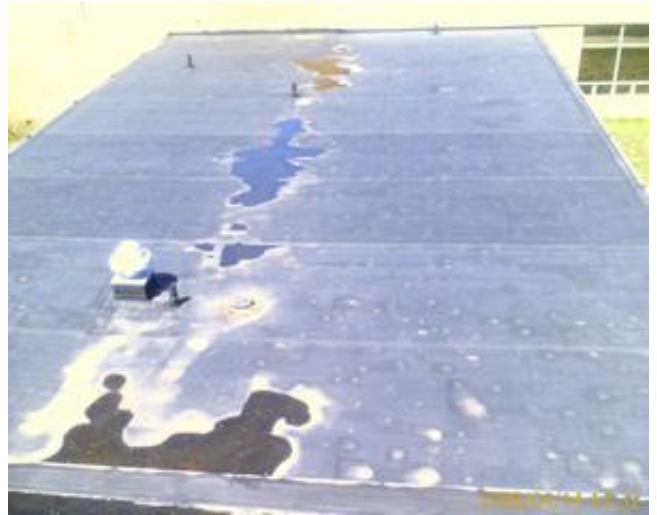
Description: The roof over the overall facility is a combination of a built-up asphalt ballasted system (no installation date was available at time of assessment), which is in fair condition, and an EPDM fully adhered membrane system that was installed in 2001, and is in good to fair condition. There are no district reports of current leaking. Signs of past leaking were observed during the physical assessment. Access to the roof was gained by a roof hatch and ladder that is good condition. There were no observations of standing water on the roof. Metal cap flashings are in good condition. Roof storm drainage is addressed through a system of roof drains, which are properly located, and in fair to good condition. The roof is not equipped with overflow roof drains though they will be required in areas of roof replacement. No problems requiring attention were encountered with any roof penetrations. There are not any covered walkways attached to this structure. April 2019 Update: Additional insulation will necessary to meet LEED Silver Certification Energy Efficiency Requirements.

Rating: 3 Needs Replacement

Typical roof drain condition

Typical roofing condition

Recommendations: The roof over the overall facility requires replacement to meet Ohio School Design Manual guidelines for age of system. To facilitate the school's compliance with OBC, provide new overflow roof drains in areas of roof replacement in the overall facility. April 2019 Update: Provide for additional roof insulation to meet LEED Silver Certification Energy Efficiency Requirements.

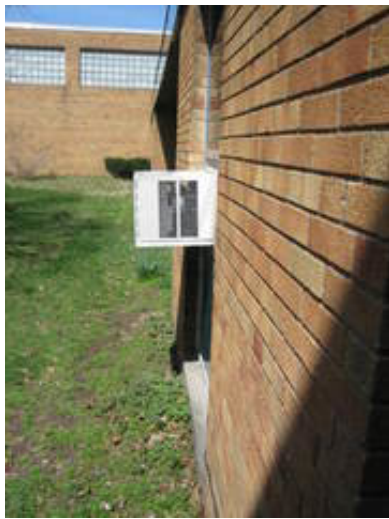
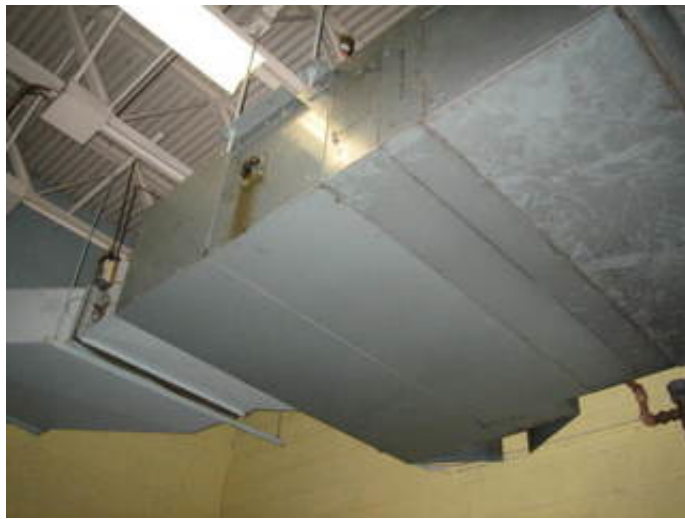
Description: The existing system for the overall facility consists of four (4) DeDietrich natural gas fired water boilers that provide hot water to unit ventilators. The system is in fair condition. The unit ventilators are original to the 1957 original construction. The gas fired boilers were replaced in 2002. Existing controls are a combination of pneumatic and digital and were installed with the 1957 original construction and partially upgraded in 2002. The system is not capable of providing Ohio Building Code fresh air requirements. The facility contains window air conditioning units in the administrative office area.

Window air conditioning unit

Gymnasium exhaust

Recommendations: Provide an air conditioning system throughout the overall facility to meet Ohio School Design Manual guidelines. Funding included in Item A - Heating System.

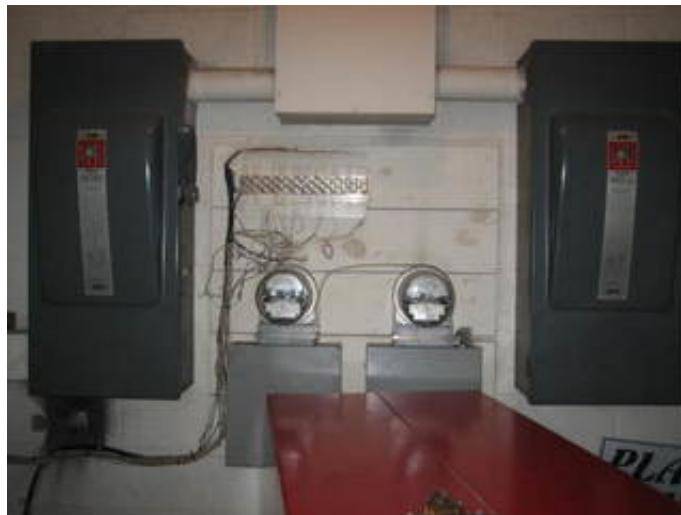
Description: The electrical system for the overall facility is twin 400-amp 240/120v, 3phase, Bulldog Electrical Products main disconnects in fair condition. The panels throughout the building are Cleveland Switchboard Panels installed with the 1957 original construction. The main disconnects were upgraded in the 1970's. The panel system is in poor condition and cannot be expanded for additional capacity. The transformer is owned by the utility company and located in a transformer vault within the building. Classrooms are not equipped with adequate electrical outlets. Corridors of the building are equipped with adequate electrical outlets for building maintenance. The exterior of the building is not equipped with adequate electrical outlets for building maintenance. The facility does not contain lightning protection with grounding. April 2019 Update: The individual line items for Transformer Removal, New Pad Mounted Transformer, Lightening Protection and Building Grounding are included in the scope and budget for complete System Replace and those individual line items should be deleted.

Rating: 3 Needs Replacement

400 amp main disconnects

Recommendations: The entire electrical system requires replacement to meet Ohio School Design Manual guidelines for classroom capacity, the addition of an air conditioning system and due to condition and age. The emergency generator for life safety systems is included in the entire electrical system replacement funded in this Item D - Electrical. Install new pad mounted transformer. Provide building lightning protection and grounding. April 2019 Update: Delete the individual line items for Transformer Removal, New Pad Mounted Transformer, Lightening Protection and Building Grounding.

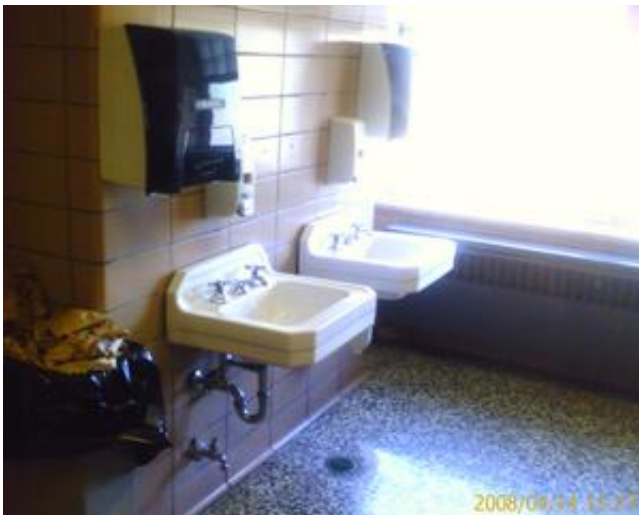
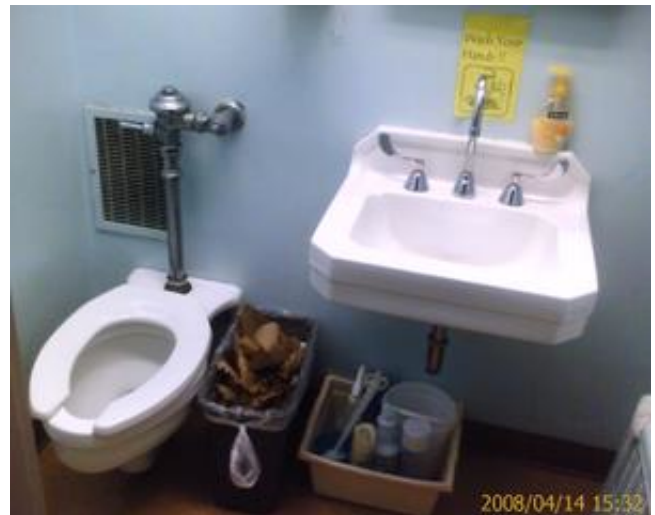
Description: A back flow preventer is not provided.? The facility does not contain a water treatment system.? Domestic supply piping is copper in fair condition.? Sanitary waste piping is cast-iron in adequate condition.The domestic water heater is a natural gas Laars unit with a large external water storage tank located in the main mechanical room.? The hot water heater was installed in 2006 and is in good condition.The school contains 2 large group restrooms for boys, 2 large group restrooms for girls, 1 locker room restroom for boys, 1 locker room restroom for girls, 2 restrooms associated with specialty classrooms, and 1 restroom for staff. Condition of fixtures is good. The facility is equipped with 6 ADA electric water coolers, in good condition.?Special education classroom is not equipped with the required restroom facilities. Kitchen is equipped with the required restroom facilities, and fixtures are in good condition.?Health clinic is equipped with the required restroom facilities, and fixtures are in good condition. Kindergarten / pre-K classrooms are equipped with the required restroom facilities, and fixtures are in good condition.Kitchen fixtures consist of 1 double and 1 3-well sinks, as well as 1 lavatory, 1 dishwasher, and 1 garbage disposal unit, which are in good condition.The school meets the OBC requirements for fixtures except for drinking fountains.? OSDM guideline requirements are not met for fixtures.? ADA requirements are not met for fixtures and drinking fountains (see Item O).? Custodial closets are properly located and are adequately provided with required service sink, which is in good condition.Science classrooms are not equipped with required utility sink, gas / compressed air connections, and safety shower / eyewash station.Adequate exterior hose bibbs are provided. April 2019 Update: Per the District Personnel, most of the domestic supply piping is galvanized. It was reported that there are ongoing issues with the sanitary waste piping and due to age and condition warrants replacement. The student population no longer included middle school students: therefore, the line items to replace the Safety Eyewash/Shower Stations and Compressed Air are no longer required. The domestic water heater is at the end of it's life expectancy and warrants replacement. District Personnel reported issues with the waterless urinals and they warrant replacement. Flush valves and faucets need replaced to meet LEDD water reduction requirements.

Rating: 2 Needs Repair

Typical fixture condition

Recommendations: Provide back flow preventer at water service entry. To facilitate the school's compliance with OBC and OSDM guideline requirements, provide new electric water coolers, wash fountains, compressed air connections, gas connections, and eyewash / safety shower stations, Due to condition and OSDM guidelines, replace 14 faucets and valves. See Item O for replacement of fixtures related to ADA requirements. See Item J for provisions on kitchen related equipment. April 2019 Update: Replace the domestic supply piping. Replace the sanitary waste piping. Delete lines items for replacing the Safety Eyewash/Shower Stations and Compressed Air piping. Replace the domestic water heater. Replace the waterless urinals. Replace flush valves and faucets.

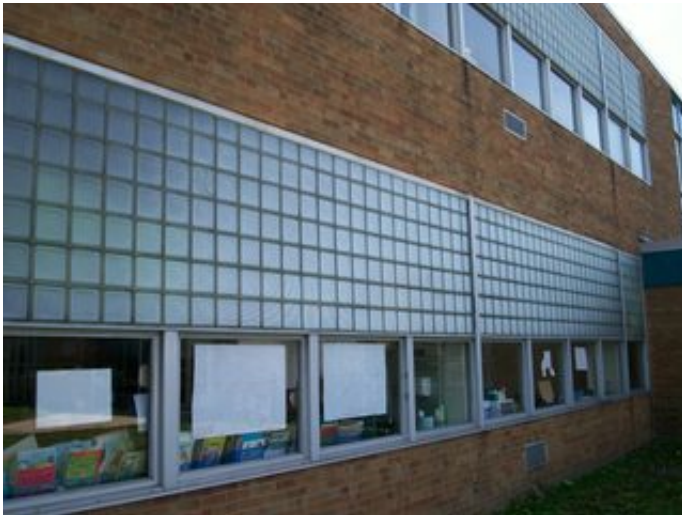
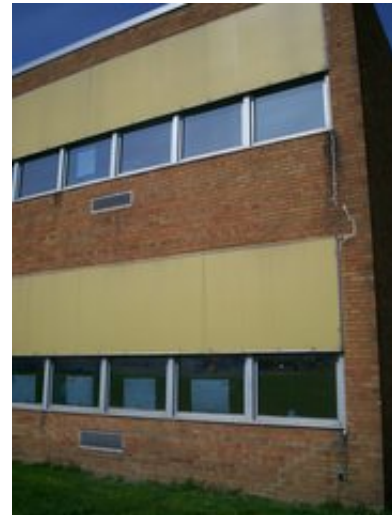
Description: The overall facility is equipped with aluminum frame windows with a single glazed window system, which was installed in 1957, and is in fair to poor condition. Window system seals are in fair to poor condition, with moderate air and water infiltration being experienced. Window system hardware is in fair condition. The window system features surface mounted blinds, which are in fair to poor condition. The window system is not equipped with insect screens on operable windows. Aluminum frame curtain wall systems are found in the overall facility in fair to poor condition. There are glass block windows in the overall facility in fair condition. A few windows have been replaced with insulated window panels, but are installed on non-thermally broken aluminum frames. The exterior doors in the overall facility are equipped with hollow metal framed sidelights and transoms with a single glazed window system, in fair to poor condition. The school does not contain skylights. Window security grilles are not provided for ground floor windows. There is a greenhouse associated with this school, and it is in good condition.

Rating: 3 Needs Replacement

Glass block and single glazed windows

Single glazed window system

Recommendations: Provide a new insulated window system with integral blinds to meet with Ohio School Design Manual requirements. Replace curtain wall system and glass block windows in the overall facility.

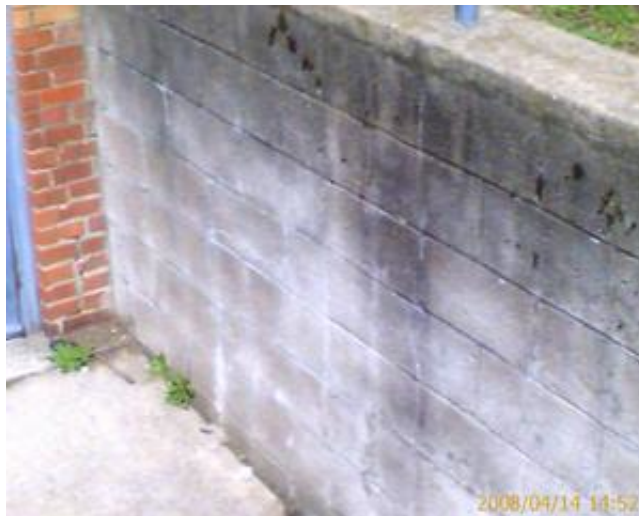
Description: The overall facility is equipped with concrete masonry unit foundation walls on concrete footings, which displayed no locations of significant differential settlement, cracking, or leaking, and are in good condition. The district reports that there has been no past leaking. No grading or site drainage deficiencies were noted around the perimeter of the structure that are contributing or could contribute to foundation / wall structural deterioration.

Typical concrete masonry unit foundation wall

Recommendations: No work required.

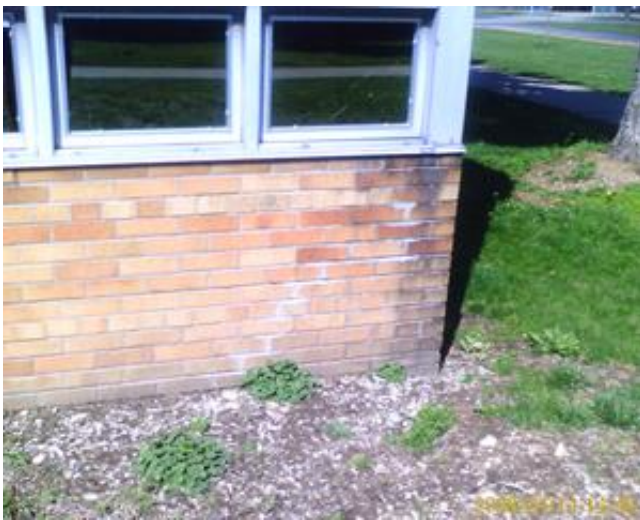
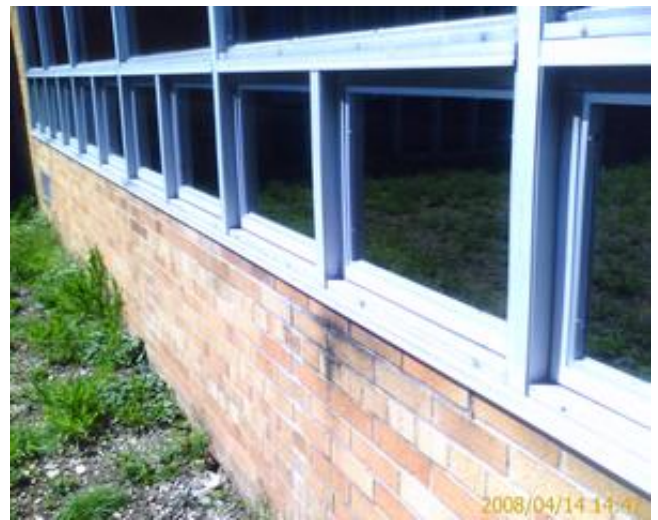
Description: The overall facility has a combination of steel framed structure and brick veneer on a masonry load bearing wall system, which displayed no locations of significant deterioration, and is in good condition. Control joints are not provided at lintel locations at doors and windows. The school does not contain expansion joints, and none are needed as there is no indication of exterior masonry cracking or separation. The exterior masonry has not been cleaned and sealed in recent years, and shows evidence of mortar deterioration in the two story portion of the building. Architectural exterior accent materials consist of metal and aluminum panels. Interior walls are masonry and plaster and are in good condition. Interior masonry appears to have adequately spaced and caulked control joints in good condition. Soffits are in good condition. The window sills are an element of the aluminum window system, and are in good condition. The exterior lintels are steel, are rusting, but are in good structural condition. Chimneys are in good condition. April 2019 Update: Per the District Personnel the incinerator vents into the masonry chimney. The budget to scrape and paint the steel lintels is inadequate. The lintels at the upper windows at the gymnasium are beginning to show signs of deterioration and should be replaced. The sf quantity for tuckpointing is inadequate. Installation of the new HVAC system will require removal of the cabinet unit heaters and masonry infill will be required at the outside air grilles. It was observed that horizontal and vertical wall cracks at the southwest stair and it's recommended a Structural Engineer evaluate this condition.

Rating: 2 Needs Repair

Typical exterior wall condition

Recommendations: Provide tuckpointing in all areas of mortar deterioration as required in the overall facility. Provide exterior masonry cleaning and sealing as required throughout the overall facility. Demolish existing chimney. April 2019 Update: Delete masonry chimney demolition line item. Increase the budget to scrape and paint the steel lintels from \$5/lf to \$10/lf. Replace the steel lintels at the upper windows at the gymnasium. Increase the sf quantity for tuckpointing from 117 sf to 1,881 sf. Provide budget to infill masonry following removal of outside are grilles. Provide allowance for Structural Engineer evaluate of southeast stair.

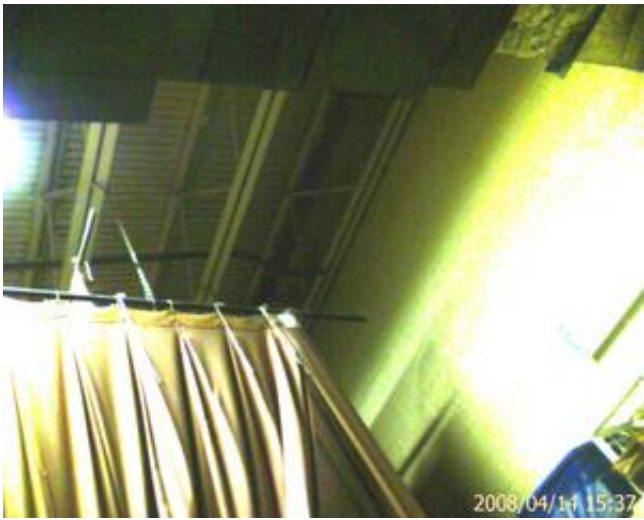
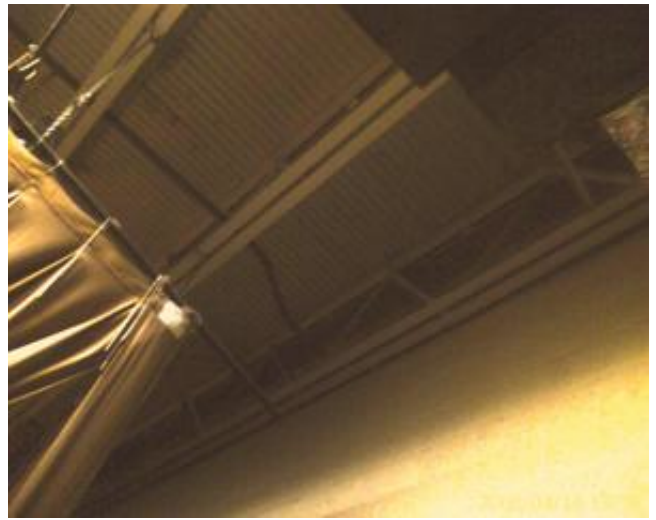
Description: The floor construction of the base floor of the overall facility is a combination of concrete slab-on-grade and metal deck with concrete topping over a crawl space type construction, and is in good condition. Crawl space is located under two story section of the facility. Although the intermediate floor structure in this facility was not open for inspection at time of assessment, overall building structure type and condition of floors in the second floor indicate that structure is of metal deck on steel joist with concrete topping and is in good condition. Ceiling to structural deck spaces are sufficient to accommodate HVAC, electrical, and plumbing scopes of work in required renovations. The roof construction of the overall facility is metal deck on steel joist type construction, and is in good condition.

Typical metal roof deck

Recommendations: No work required.

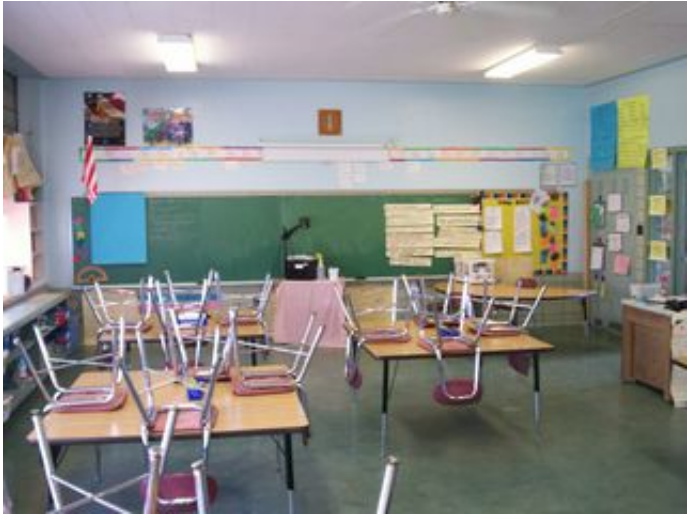
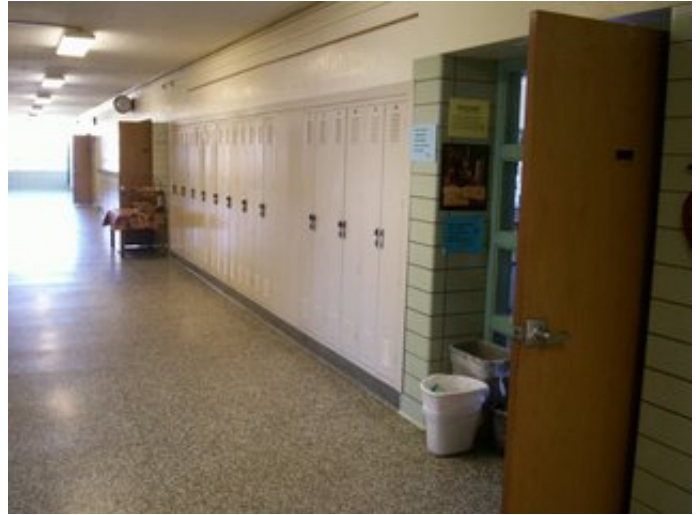
Description: The overall facility features conventionally partitioned classrooms with VAT flooring, acoustical tile ceilings, and glazed block and plaster type wall finishes, which are in fair to poor condition. Corridors have terrazzo flooring, acoustical tile ceilings, and glazed block and plaster type wall finishes, which are in fair to poor condition. Restrooms have terrazzo flooring, plaster type ceilings, and glazed block type wall finishes, which are in fair to poor condition. Toilet partitions are stone type construction with metal and wood type doors that are in fair to poor condition. Classroom casework in the overall facility consists of miscellaneous wood and metal shelving units, is inadequately provided, and in poor condition. Classrooms are provided with adequate chalkboards, markerboards, and tackboards, which are in fair condition. The lockers, located in the corridors, are adequately provided, and in fair condition. The art program is not equipped with a kiln. The facility is equipped with wood non-louvered interior doors that are partially recessed with proper ADA clearances, and are equipped with a combination of non-ADA and ADA-compliant hardware, and are in fair condition. The gymnasium space has wood type flooring, plaster ceilings, and glazed block and painted block type wall finishes, which are in fair condition. Gymnasium basketball backboards are manually operated type, and are in fair to poor condition. The media center has carpet flooring, acoustical tile ceilings, and glazed block and plaster type wall finishes, and they are in fair condition. Student dining has sheet vinyl flooring, acoustical tile ceilings, and plaster type wall finishes, and they are in fair to poor condition. The existing kitchen is full service, is undersized based on current enrollment, and the existing equipment has an unknown installation date, and is in poor condition. A walk-in freezer is located on the building's exterior, and is in fair condition. A reach-in cooler is located within the kitchen space, and is in fair condition. April 2019 Update: Additional wall insulation required to meet LEED Silver Certification Energy Efficiency requirements. Operable partition wall in student dining is worn, dated and warrants replacement. The middle school portion of complete replacement is no longer applicable and should be changed to reflect elementary only. Floor and wall patch will be required following removal of floor mounted urinals.

Rating: 3 Needs Replacement

Typical classroom finishes

Typical corridor finishes

Recommendations: Provide complete replacement of finishes and casework due to installation of systems outlined in Items A, C, D, E,K, L, M, N, T, U, and due to condition. Provide funding for replacement of interior doors due to condition. Provide for repairs to terrazzo flooring due to condition. Provide for removal and replacement of wood flooring in the gymnasium due to age and condition. Provide for replacement of toilet partitions due to work outlined in Item O, and due to condition. Provide for replacement of toilet accessories due to age and condition. Provide for replacement of kitchen equipment due to age and condition of equipment. April 2019 Update: Provide for additional wall insulation. Replace operable wall in student dining. Delete middle school line item for complete replacement and revise to reflect elementary. provide for floor and wall patch following removal of floor mounted urinals.

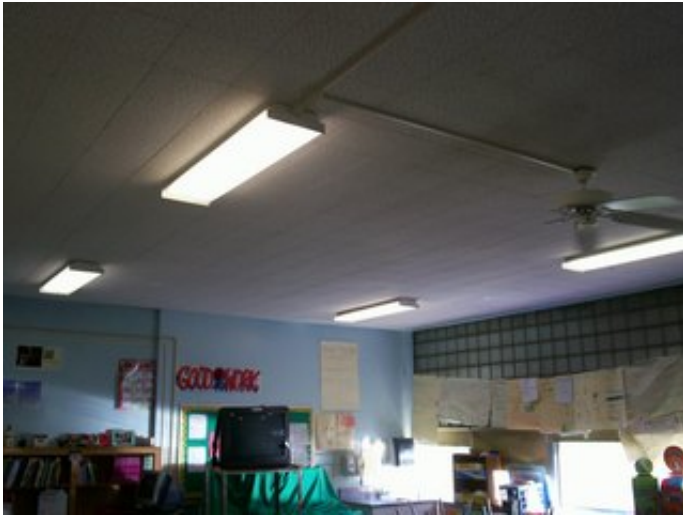
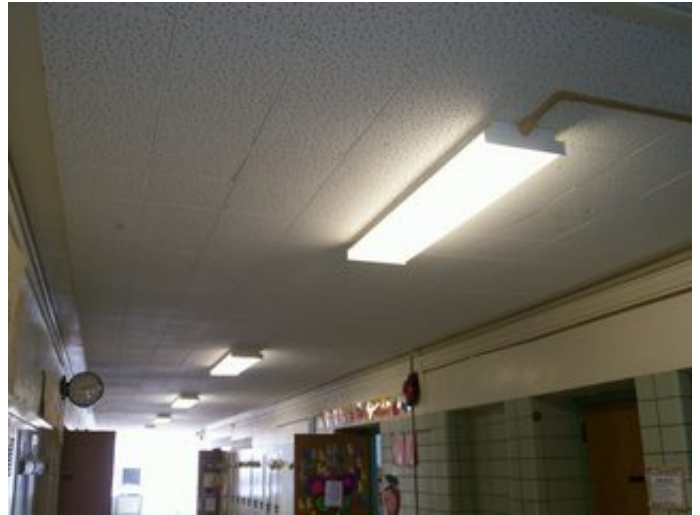
Description: The typical classrooms in the overall facility are equipped with 1x4 surface mount fluorescent fixtures with dual level switching. Classroom fixtures are in fair condition, providing an average illumination of 28 FC, which is less than the 50 FC recommended by the OSDM. The typical corridors in the overall facility are equipped with 1x4 surface mount fluorescent fixtures with dual level switching. Corridor fixtures are in fair condition, providing an average illumination of 26 FC, thus complying with the 20 FC recommended by the OSDM. The gymnasium space is equipped with recessed fluorescent type lighting, in fair to poor condition, providing an average illumination of 30 FC, which is less than the 50 FC recommended by the OSDM. The media center is equipped with 2x4 surface mount fluorescent fixture type lighting in fair condition, providing an average illumination of 100 FC, thus complying with the 50 FC recommended by the OSDM. The student dining spaces are equipped with 1x4 surface mount fluorescent fixture type lighting with multi level switching. Student dining fixtures are in fair condition, providing an average illumination of 32 FC, which is less than the 50 FC recommended by the OSDM. The kitchen space is equipped with 1x4 surface mount fluorescent fixture type lighting with multi level switching. Kitchen fixtures are in fair condition, providing an average illumination of 89 FC, thus complying with the 75-80 FC recommended by the OSDM. The service areas in the overall facility are equipped with 1x4 surface mount fluorescent fixture type lighting in fair condition. The typical administrative spaces in the overall facility are equipped with 1x4 surface mount fluorescent fixture type lighting in fair condition, providing adequate illumination based on OSDM requirements. The overall lighting systems of the facility are not fully compliant with Ohio School Design Manual requirements due to age and condition, and inadequate lighting levels.

Rating: 3 Needs Replacement

Typical classroom lighting

Typical corridor lighting

Recommendations: Provide complete replacement of lighting system due to condition, lighting levels, and installation of systems outlined in Items A, C, D, J, L, M, N, and U.

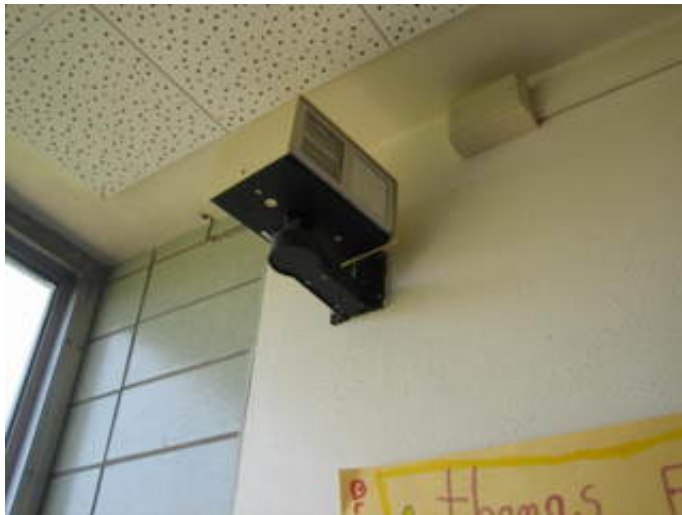
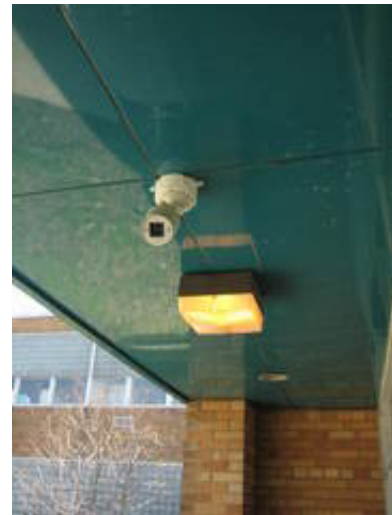
Description: The overall facility contains a security system consisting of entry mounted security cameras that are monitored in the administrative office area, door contacts and motion sensors. The main entrance door contains an electric door strike monitored by the administrative staff. The existing security system is in fair condition. The exterior security lighting consists of minimal wall mounted light fixtures and soffit light fixtures at a few of the building exit doors. Exterior security lighting is in poor condition and does not provide adequate coverage. April 2019 Update: The main entry does not have adequate security control for visitor access. Complete security system required.

Rating: 3 Needs Replacement

Corridor mounted motion sensor

Entrance security camera

Recommendations: Provide additional building security systems as desired from the district to more thoroughly protect the building during school hours and after school hours. delete partial system replacement and add complete system replacement. Provide new exterior security lighting system to meet Ohio School Design Manual guidelines. April 2019 Update: Provide for a security vestibule.

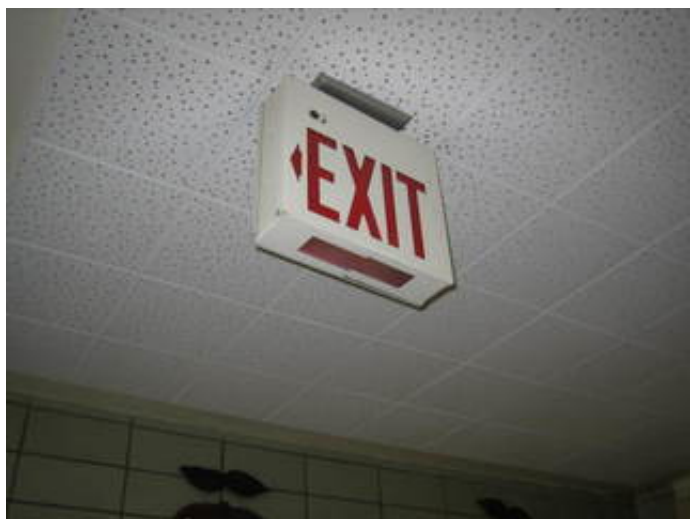
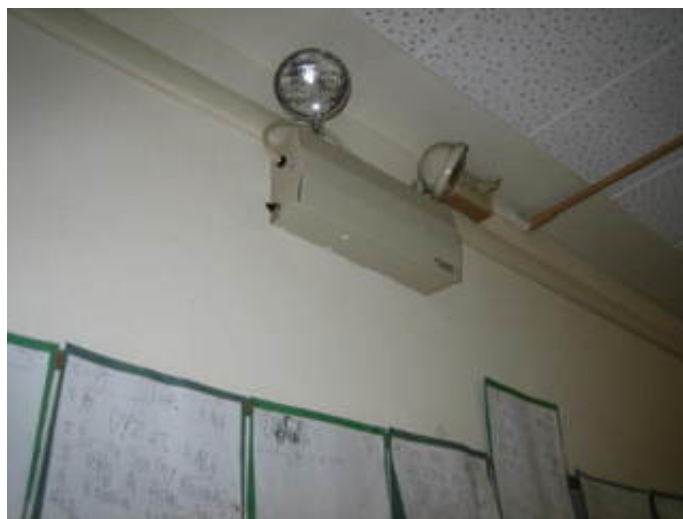
Description: The overall facility does contain an emergency/egress lighting system with a combination of battery backup within the fixture and fixtures without provisions for battery backup. The system is in poor condition and does not provide adequate illumination.

Rating: 3 Needs Replacement

Ceiling mounted exit signage

Corridor mounted emergency lighting

Recommendations: Provide complete replacement of emergency/egress lighting system to meet Ohio School Design Manual guidelines. Emergency power generator is funded under Item D - Electrical.

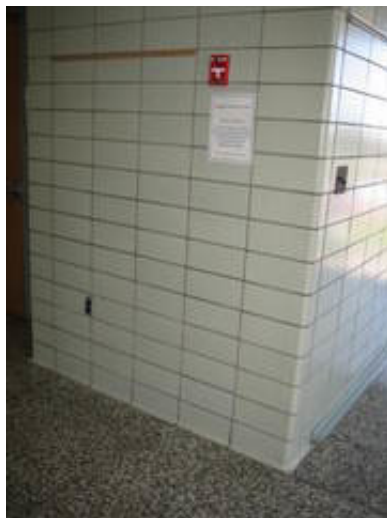
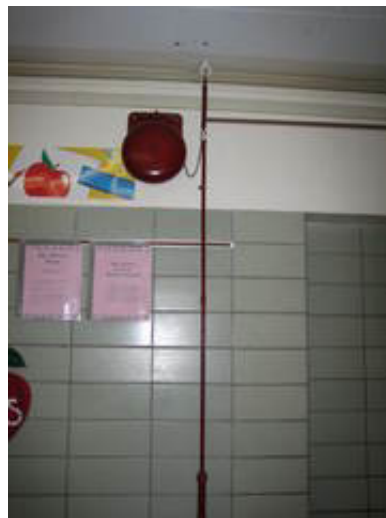
Description: The overall facility contains a fire alarm system in poor condition. Manual pull stations are mounted in corridors, but not at ADA compliant heights. Manual pull stations are not adjacent to exit doors. Horns and strobes are not mounted in classrooms, corridors, assembly areas or mechanical areas. Mechanical equipment does not contain automatic fire alarm devices. The system does not have additional zone capabilities. The system is not adequately provided throughout the facility. The fire alarm system does not meet NFPA requirements and Ohio School Design Manual guidelines.

Rating: 3 Needs Replacement

Fire alarm pull mounted high on wall

Manual fire alarm bell

Recommendations: Provide complete replacement of fire alarm system consisting of manual fire alarm pull stations mounted at required heights, remote annunciator panels, automatic fire detection devices in all air devices and mechanical equipment, and horn/strobe devices located in all occupied spaces to meet Ohio School Design Manual guidelines.

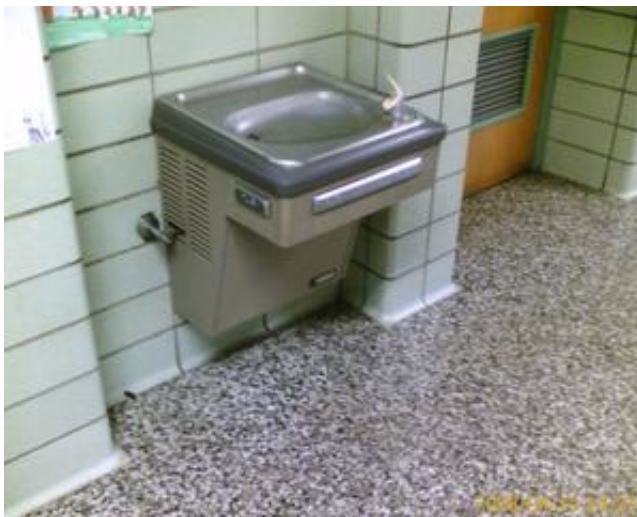
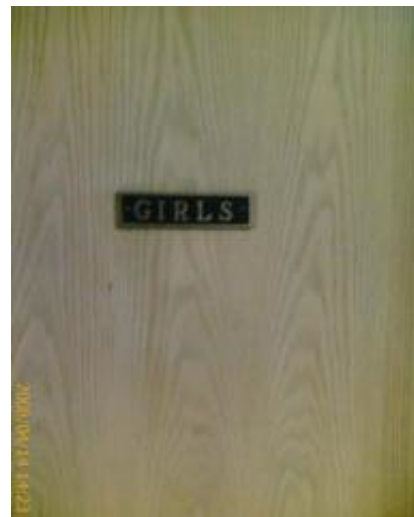
Description: At the site, there is an accessible route provided from the public right-of-way, the accessible parking areas, and from the passenger unloading zone to the main entrance of the school. There is an accessible route connecting all or most areas of the site. The exterior entrances are ADA accessible. Access from the parking / drop-off area to the building entries is not compromised by steps or steep ramps. Adequate handicap parking is not provided. Exterior doors are equipped with ADA hardware. The main entry is equipped with an ADA power assist door, which is in good condition. Playground layout and equipping are mostly compliant. On the interior of the building, space allowances and reach ranges are mostly compliant. There is an accessible route through the building which does include protruding objects. Ground and floor surfaces are compliant. Ramps and stairs do not meet all ADA requirements, and are insufficient due to railing configurations. This multistory building has a compliant elevator that accesses every floor and is in good condition. Access to the stage is not facilitated by a chair lift or ramp. Interior doors are recessed, are mostly provided adequate clearances, and are mostly provided with ADA-compliant hardware. 16 ADA-compliant toilets are required, and 1 is currently provided. 16 ADA-compliant lavatories are required, and 0 are currently provided. 6 ADA-compliant urinals are required, and 0 are currently provided. 4 ADA-compliant showers are required, and 0 are currently provided. 6 ADA-compliant electric water coolers are required, and 6 are currently provided. Toilet partitions are metal, and do not provide appropriate ADA clearances. ADA-compliant accessories are not adequately provided and mounted. Mirrors do not meet ADA requirements for mounting heights. Health clinic and kindergarten classroom restrooms are not compliant with ADA requirements. Special education classrooms are not provided with the required restroom facility. ADA signage is not provided on the interior and the exterior of the building.

Rating: 3 Needs Replacement

Typical electric water cooler

Typical non ADA compliant signage

Recommendations: Provide new ADA-compliant signage, chair lifts, toilets, lavatories, urinals, showers, toilet partitions, and mirrors, as well as replace showers and rework narrow door openings to facilitate the school's meeting of ADA requirements. Parking issues are corrected in Item P. Exterior door hardware issues are corrected in Item S. Stair railing issues are corrected under Item U. Toilet accessories are addressed under Item J.

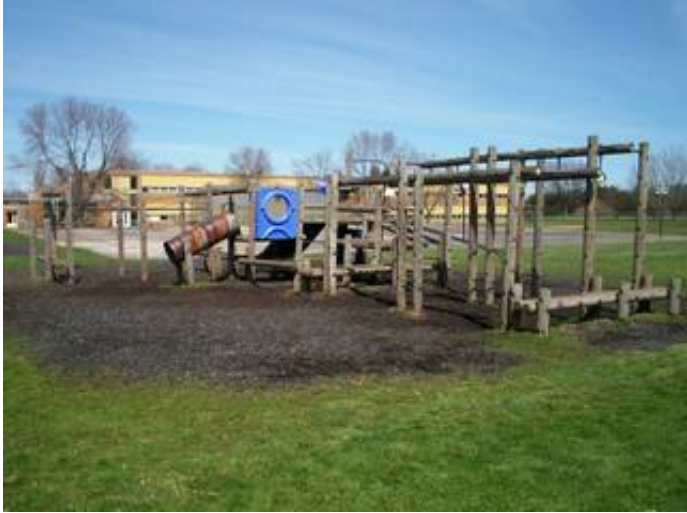
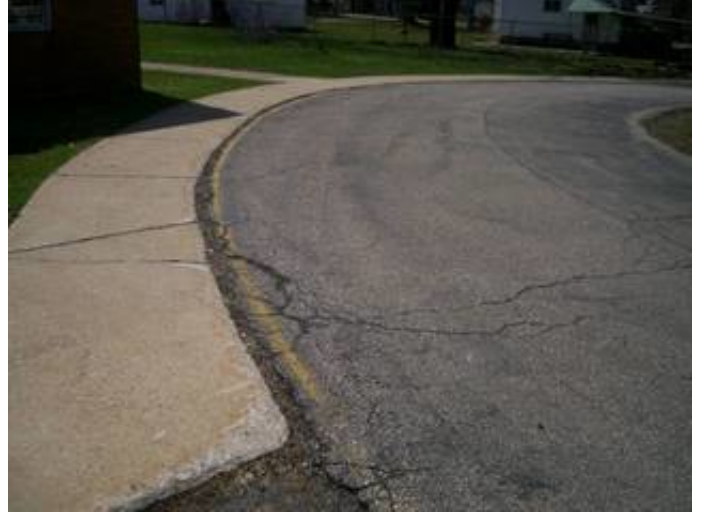
Description: The 8 acre flat site is located in a small town residential and commercial setting with moderate tree and shrub type landscaping. There are no apparent problems with ponding. Limited areas of erosion were observed at edges of sidewalks and pavement. A separate, detached greenhouse is located on the south side of the school. The site is bordered by lightly traveled city streets. Two entrances onto the site facilitate proper separation of bus and other vehicular traffic, and one-way bus traffic is provided. There is a curbside bus loading and unloading zone in front of the school, which is separated from other vehicular traffic. Staff and visitor parking is facilitated by multiple asphalt parking lots in fair condition, containing 99 parking places, which provides adequate parking for staff members and visitors. Parking for the disabled is not adequately provided. The site and parking lot drainage design, consisting of sheet drainage, catch basins, and storm sewers, provides adequate evacuation of storm water, and no problems with parking lot ponding were observed. Concrete curbs are not located as required. Trash pick-up and service drive pavement is heavy duty, is not equipped with a concrete pad area for dumpsters, and is in fair condition. Concrete sidewalks are properly sloped, are located to provide a logical flow of pedestrian traffic, and are in fair condition. The playground area is partially fenced for security, and is provided with adequate separation from vehicular traffic. The playground equipment is wood and metal type construction in fair to poor condition, placed to provide compliant fall zones, and on a compliant soft surface of insufficient depth, with a hard surface play area being provided on an asphalt surface. The athletic facilities are comprised of a multipurpose field and softball field, and are in fair condition. Guardrails, located at the ramp to the gymnasium basement, do not meet OBC requirements. Site features are suitable for outdoor instruction, though no related equipment has been provided to facilitate doing so. April 2019 Update: Budget for playground equipment is inadequate. Asphalt is in poor condition. Fencing around playground equipment is in poor condition and should be replaced. The fencing around playground equipment is in poor condition and should be replaced. Soft surface playground required.

Rating: 3 Needs Replacement

Wood playground equipment

Sidewalk and asphalt pavement

Recommendations: Provide playground equipment to replace existing equipment. Provide for removal of playground equipment. Provide additional soft surface playground material to meet current safety requirements. Provide asphalt surface course for asphalt pavement in fair condition, including adequate provisions for the disabled. Provide for replacement of concrete sidewalks in poor condition. Provide concrete curbs to delineate vehicular traffic patterns, and to meet OSDM guidelines. Provide heavy duty concrete pavement at the dumpster pad. Provide soil stabilization measures to eliminate erosion. Provide for replacement of guardrails that do not meet OBC requirements. Provide site contingency allowances for unforeseen conditions. April 2019 Update: Revise sf quantity for playground equipment from 24,792 sf to 49,584 sf. Replace playground fencing. Replace heavy duty asphalt and light duty asphalt. Provide for soft surface playground surface.

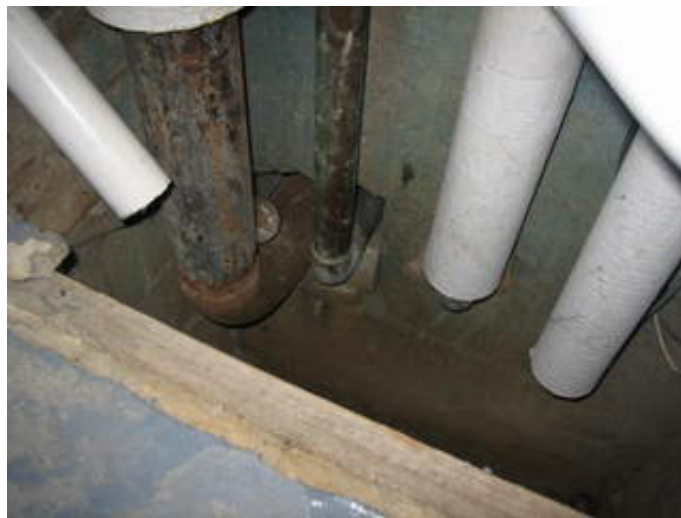
Rating: 2 Needs Repair

Water service entry

Recommendations: Increase water service size for fire protection which is included in the cost of the fire suppression system installation funded under Item U - Life Safety. Install back flow preventer to meet OBC requirements. Back flow preventer funded under Item E - Plumbing and Fixtures. Provide funding for water quality testing.

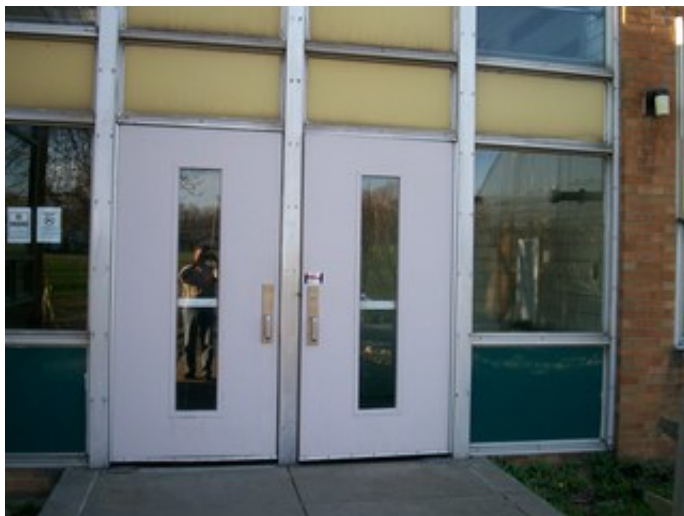
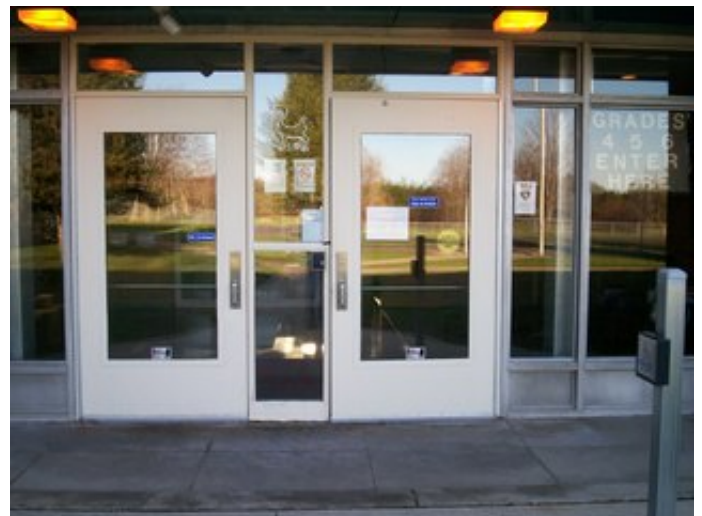
Description: Typical exterior doors in the overall facility are hollow metal type construction, installed on hollow metal frames, and in fair to poor condition. Typical exterior doors feature single glazed tempered glass vision panels or no vision panels. Entrance doors in the overall facility are hollow metal type construction, installed on hollow metal frames, and in fair to poor condition. Typical entrance doors feature single glazed tempered glass vision panels. There are no overhead doors in the facility.

Rating: 3 Needs Replacement

Exterior door system

Entrance doors

Recommendations: Replace all exterior doors to comply with Ohio Building Code, ADA, and Ohio School Design Manual guidelines, and due to condition.

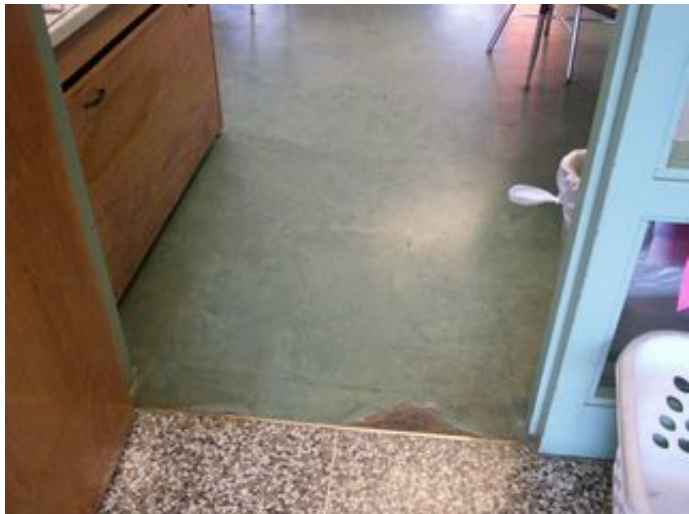
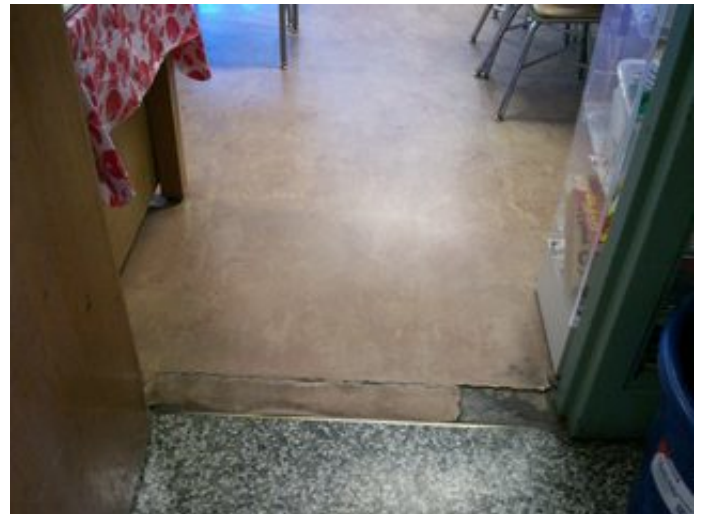
VAT in classroom

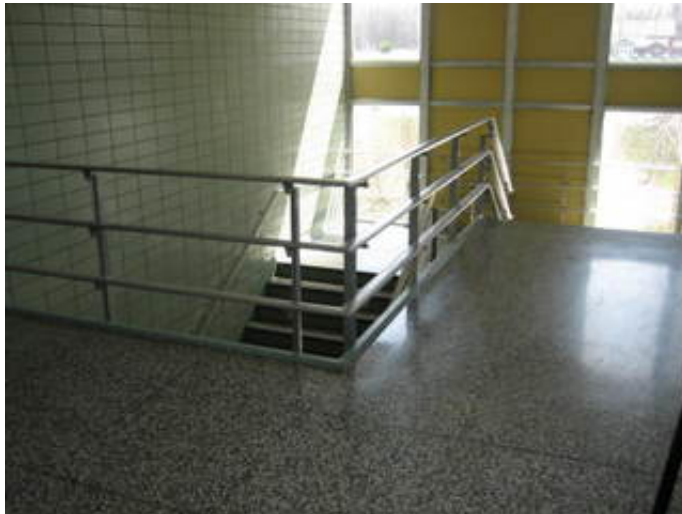
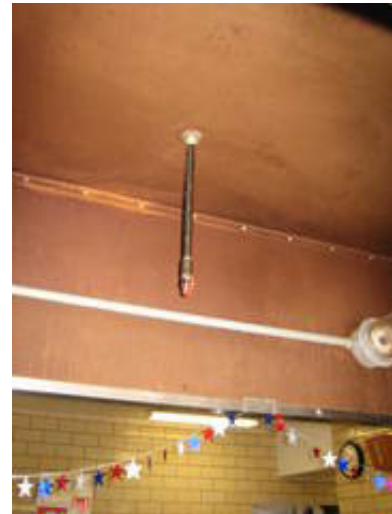
Open stair and non-compliant rails

Kitchen hood fire suppression

Recommendations: Provide an automatic fire suppression system to meet Ohio School Design Manual guidelines. Provide interior stairwell enclosures to meet Ohio School Design Manual guidelines. Provide new handrails at interior stairways to meet Ohio School Design Manual guidelines at all locations except the stairs adjacent to the new elevator. Provide new water main and tap to provide adequate pressure and volume of water for fire suppression system. Emergency generator is included in total electrical system replacement funded under Item D - Electrical. Provide fire extinguishers and cabinets adequately spaced and mounted at required ADA mounting heights. New kitchen hood with fire suppression is included in complete kitchen equipment replacement funded under Item J - General Finishes. April 2019 Update: Provide Backflow Preventer for new dedicate water line. Revise square foot cost for fire extinguisher cabinets from \$0.12/sf to \$0.50/sf.

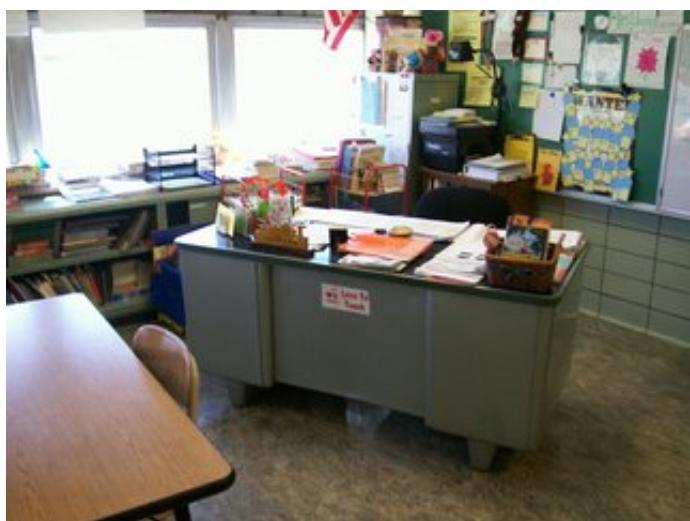
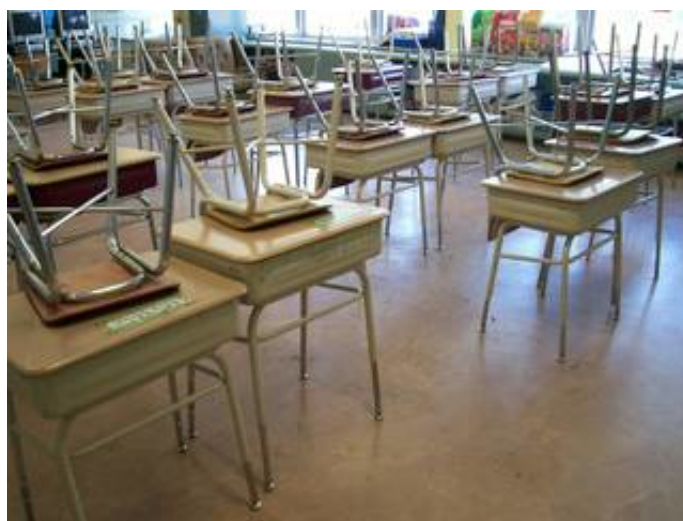
Teacher workstation in classroom

Student desk and chair in classroom

Recommendations: Provide for replacement of outdated or inadequate furniture.

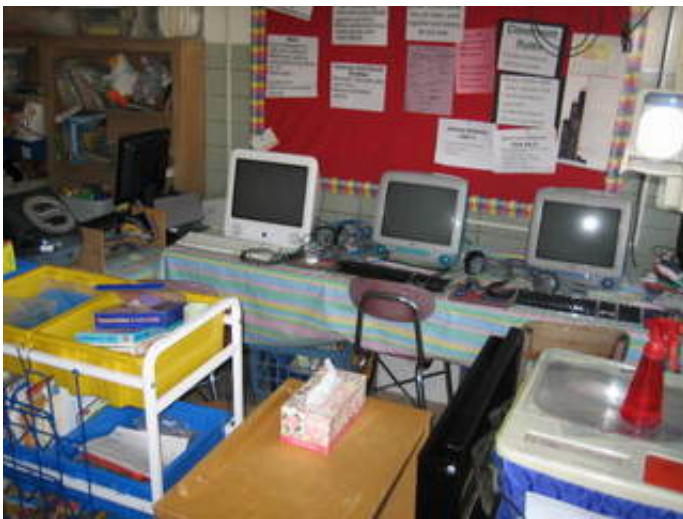
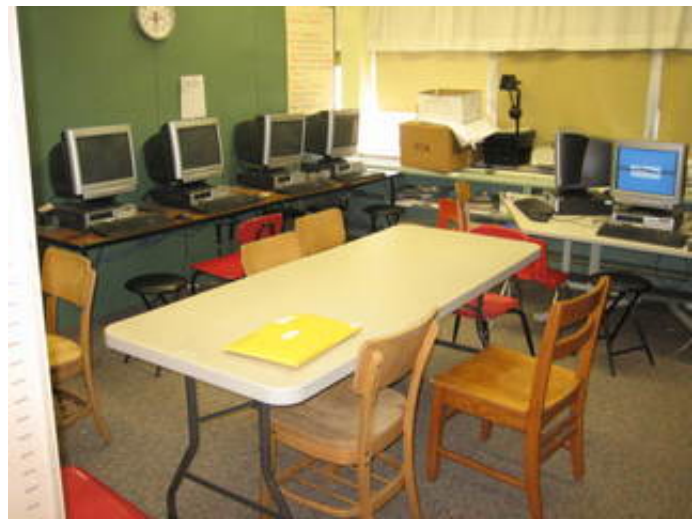
Typical classroom computers

Media center computer lab

Recommendations: Provide technology upgrades, wiring and systems per Ohio School Design Manual guidelines. April 2019 Update: Delete middle school line item and include total replacement for elementary students.
