Building Information - Buckeye Local SD (45856) - Edgewood High School

Building Pictures - Buckeye Local SD(45856) - Edgewood High School(9936)

Building Construction Information - Buckeye Local SD (45856) - Edgewood High School (9936)

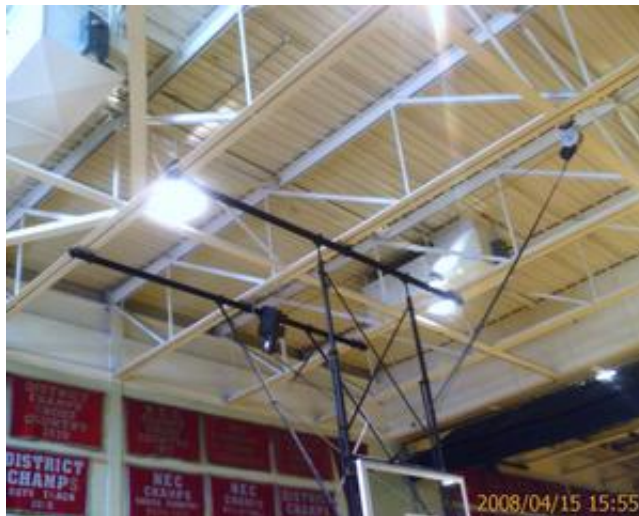
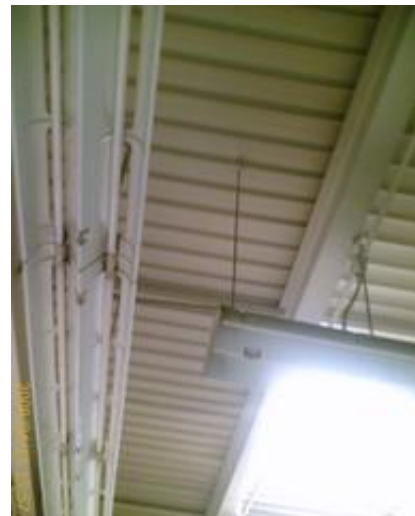
Typical metal deck roof structure

Recommendations: No work required.

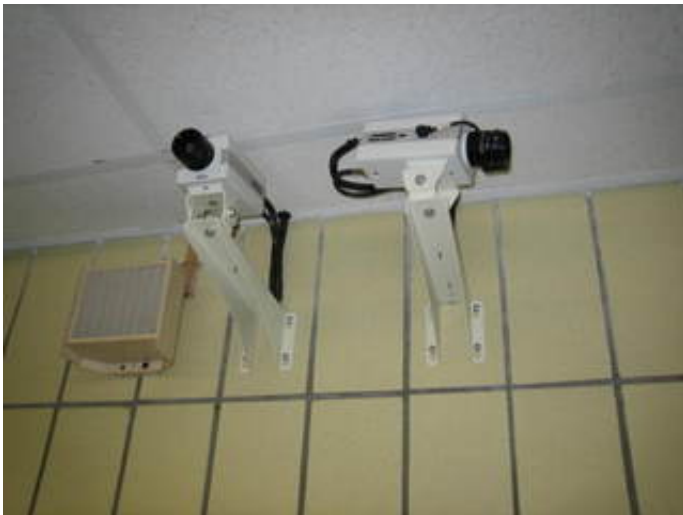
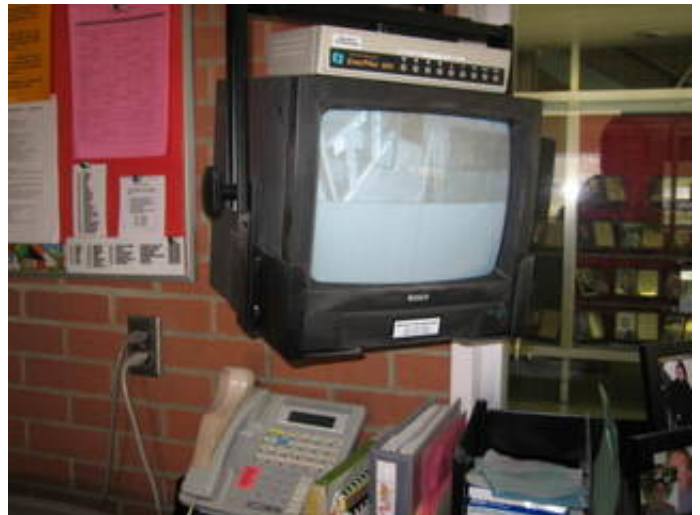
Corridor mounted security cameras

Security camera monitor

Recommendations: Provide additional building security systems as desired from the district to more thoroughly protect the building during school hours and after school hours. Provide additional exterior security lighting to meet Ohio School Design Manual guidelines. April 2019 Update: Provide budget for security vestibule. Delete partial system replacement and add complete replacement. Delete partial site lighting replacement and add complete exterior lighting replacement

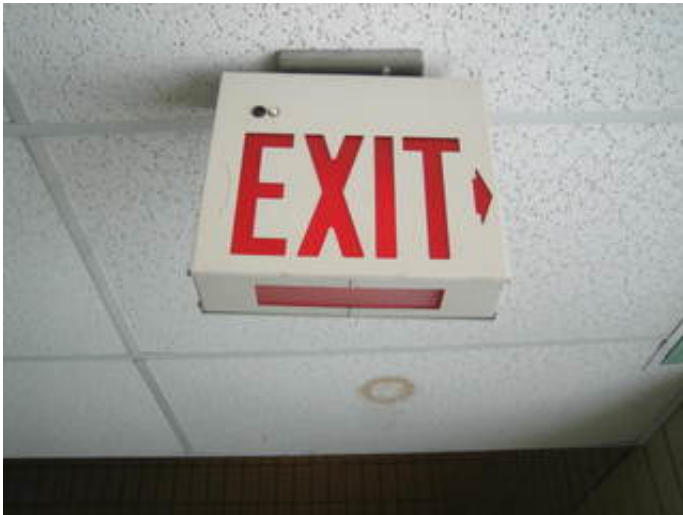
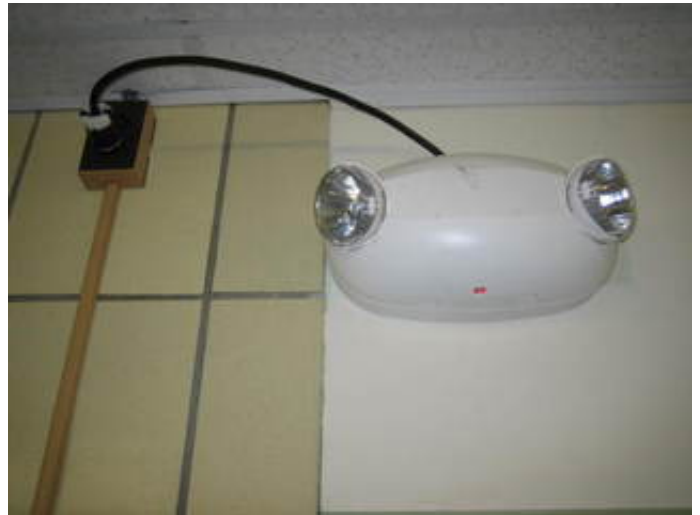
Ceiling mounted exit signage

Emergency lighting fixture

Recommendations: Emergency power generator is funded under Item D - Electrical. Provide additional exit signage as required to satisfy local fire and building officials as well as Ohio Building Code. Provide exit signage on separate electrical circuits. Supplement battery backup wall mounted emergency lighting fixtures to increase lighting levels in corridors and egress paths to at least 1.5 foot candles in all areas.

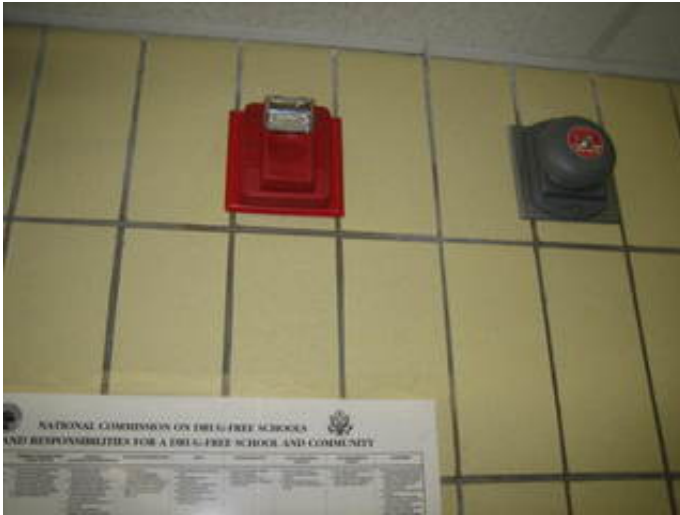
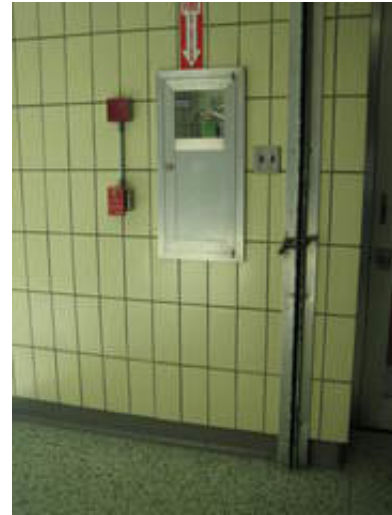
Corridor mounted horn/strobe device

Fire alarm pull station

Recommendations: Provide complete replacement of fire alarm system consisting of manual fire alarm pull stations mounted at required heights, remote annunciator panels, automatic fire detection devices in all air devices and mechanical equipment, and horn/strobe devices located in all occupied spaces to meet Ohio School Design Manual guidelines.

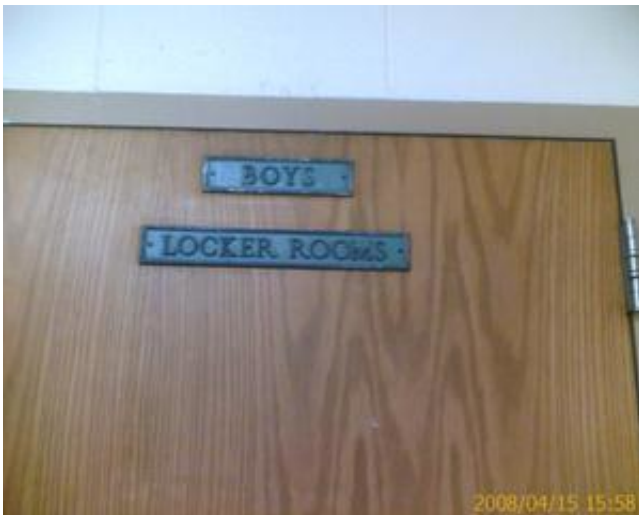
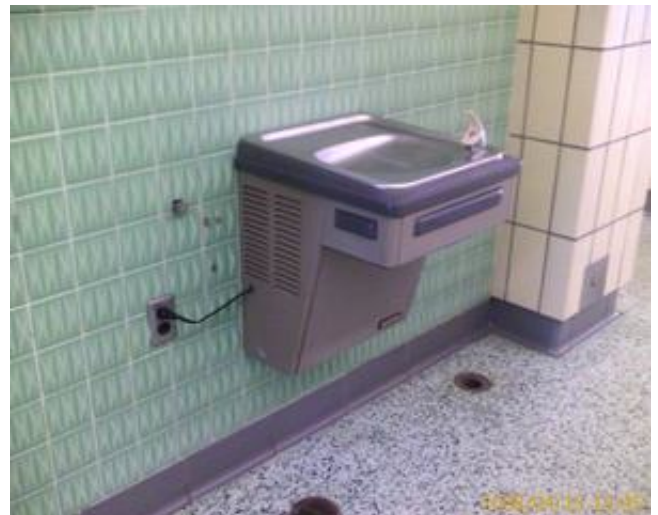
Typical signage

Typical electric water cooler

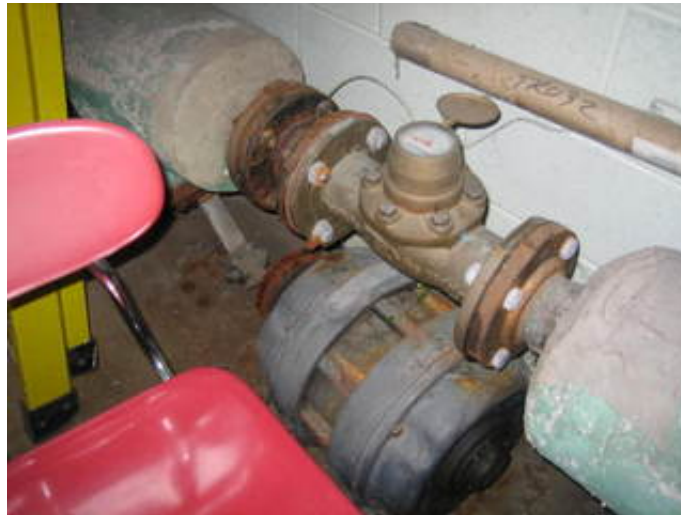
Water service entry

Recommendations: Increase water service size for fire protection which is included in the cost of the fire suppression system installation funded under Item U - Life Safety. Install back flow preventer to meet OBC requirements. Back flow preventer funded under Item E - Plumbing and Fixtures. Replace domestic water main. Provide funding for water quality testing.

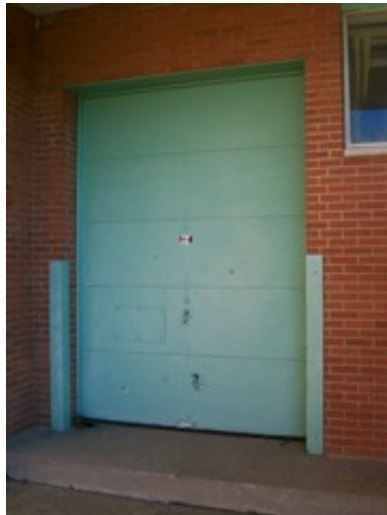
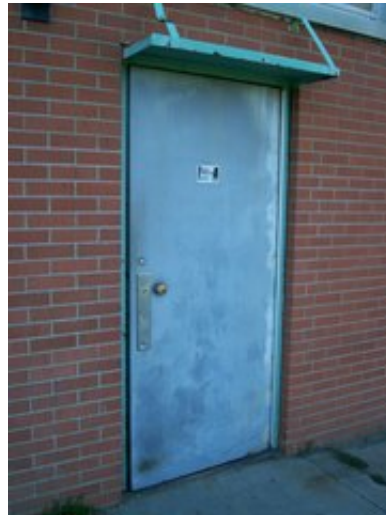
Overhead door

Exterior door

Recommendations: Replace all exterior doors to comply with Ohio Building Code, ADA, and Ohio School Design Manual guidelines, and due to condition. Replacement of single glazed door vision panels, transoms, and sidelights is addressed in Item F. No work is required in the 1961 auditorium and 1972 media center addition, as no exterior doors are located in these areas. April 2019 Update: Increase overhead door replacement from 3 to 4.

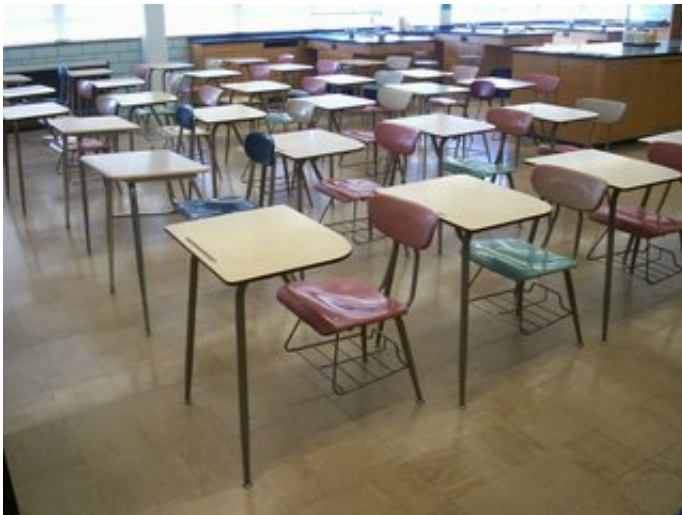
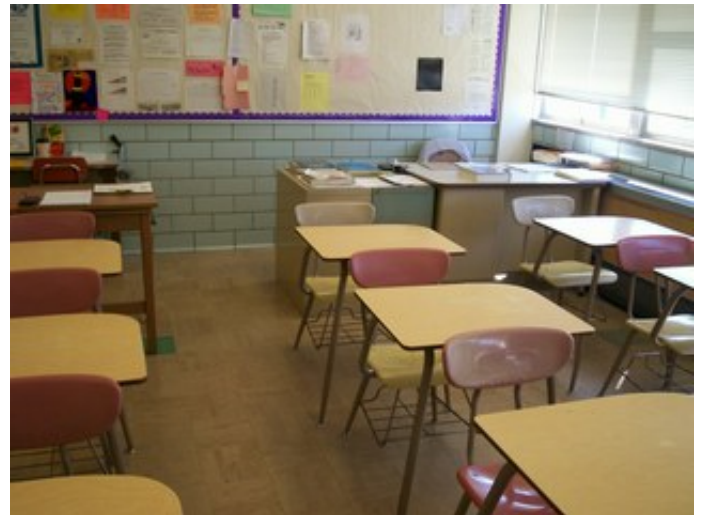
Student desk and chair in classroom

Teacher desk and chair in classroom

Recommendations: Provide for replacement of outdated or inadequate furniture. April 2019 Update: Increase the loos furnishings from \$4/sf to \$6.50/sf

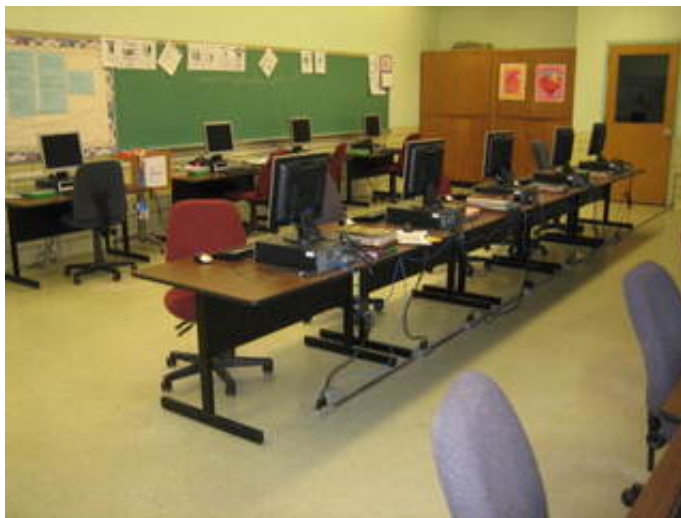
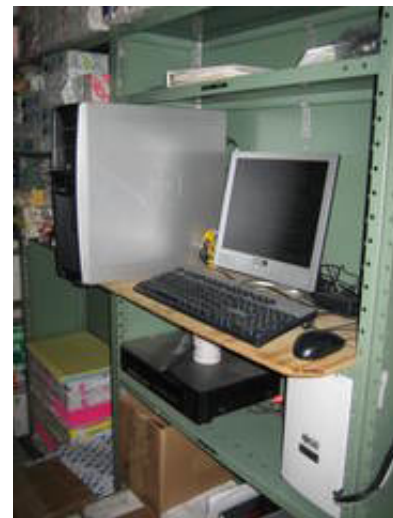
Business computer lab

Security data collection system

Recommendations: Provide technology upgrades, wiring and systems per Ohio School Design Manual guidelines.
